## Grounding Caption

## Medical Report

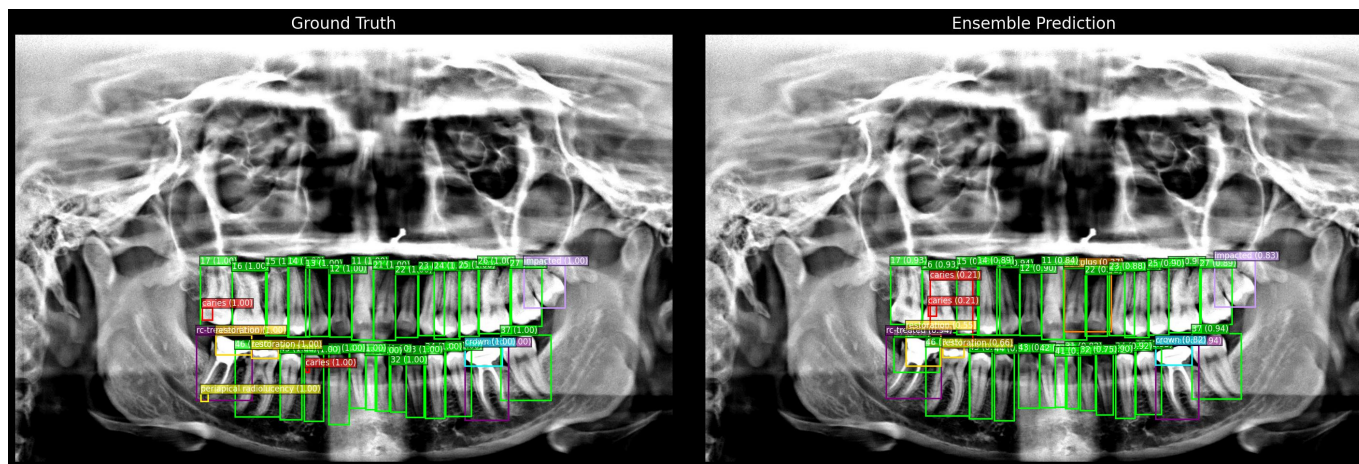
This localization caption provides multi-dimensional spatial analysis of anatomical structures and pathological findings for this panoramic dental X-ray image, including:

```
[
  {'box_2d': [568, 617, 675, 783], 'tooth_id': '16', 'label': 'caries', 'score': 0.21},
  {'box_2d': [906, 585, 1025, 748], 'tooth_id': '21', 'label': 'calculus', 'score': 0.37},
  {'box_2d': [1287, 568, 1390, 686], 'tooth_id': 'unknown', 'label': 'impacted', 'score': 0.83, 'near_tooth': '27'},
  {'box_2d': [563, 682, 583, 709], 'tooth_id': 'unknown', 'label': 'caries', 'score': 0.21, 'near_tooth': '16'}
]
```

```
[
  {'box_2d': [456, 756, 596, 916], 'tooth_id': '47', 'label': 'rc-treated', 'score': 0.94},
  {'box_2d': [507, 756, 594, 835], 'tooth_id': '47', 'label': 'restoration', 'score': 0.55},
  {'box_2d': [1138, 783, 1246, 970], 'tooth_id': 'unknown', 'label': 'rc-treated', 'score': 0.94, 'near_tooth': '35'},
]
```

```
{'box_2d': [1138, 781, 1229, 833], 'tooth_id': 'unknown', 'label': 'crown', 'score': 0.82, 'near_tooth': '35'},  
{'box_2d': [600, 788, 653, 812], 'tooth_id': 'unknown', 'label': 'restoration', 'score': 0.66, 'near_tooth': '46'}  
]
```

- A total of 27 teeth are visualized, with no wisdom teeth present.
- The dentition demonstrates normal alignment and spacing, though limited data on eruptive status is available due to absence of third molars.

- **Tooth #16:** Suspicious for caries in the mesial aspect.
- **Tooth #21:** Calculus deposits noted on the distal surface.
- **Near tooth #27:** Clear indication of impacted tooth structure in the posterior mandible.
- **Near tooth #16:** Areas of concern for caries adjacent to the distal root.

- **Tooth #47:** Presence of root canal-treated tooth with associated restoration.
  - **Near tooth #35:** Crown placement observed, with root canal-treated tooth confirmed.
  - **Near tooth #46:** Restoration noted on the buccal surface.
-

- Impacted structure near tooth #27 requires evaluation for surgical planning.
- Suspected caries on #16 and #21 demand urgent diagnostic confirmation (e.g., digital radiography or clinical inspection).

- Reinforce oral hygiene protocols to mitigate calculus accumulation on #21.
- Monitor the suspicious caries near #16 for progression with biannual imaging.

- Schedule a 6-month recall for re-evaluation of impacted structures and carious lesions.
- Refer to an endodontist for assessment of the root canal-treated tooth near #35.
- Advise immediate intervention for #16 and #21 to prevent pulpal involvement.
