Grounding Caption

ORAL PANORAMIC X-RAY EXAMINATION REPORT

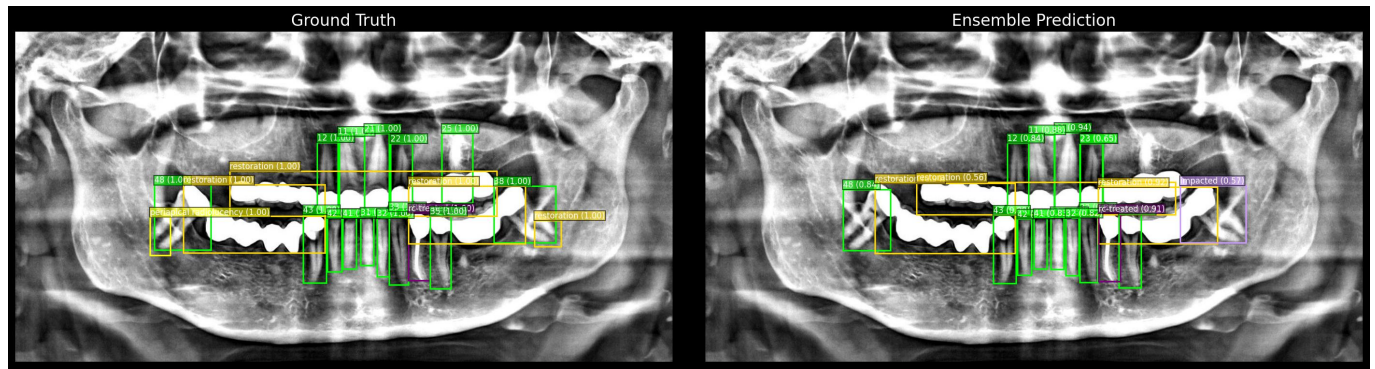
- **Total visualized teeth:** 13 (FDI numbering: #11, #12, #21, #22, #23, #31, #32, #33, #35, #41, #42, #43, #48).
- **Wisdom teeth:** One visualized (#48, non-impacted); others not identified within visible field.

- **Overall dentition:** Partially intact with no evidence of extensive periodontal loss or severe alveolar resorption.

- **Tooth #35:** Suspicious for impacted tooth *near* #35 (confidence <0.80).
- No evidence of periapical radiolucency, caries, or calculus within visualized teeth.

- **Restorations:**
 - Presence of restoration *near* #43.
 - Presence of restoration *near* #35.
 - Presence of restoration *near* #11.
 - **Root canal treatment (rc-treated):**
 - Rc-treated tooth *near* #33.
-

- **Impacted tooth suspiciously noted near #35** requires clinical correlation and radiographic evaluation for definitive diagnosis and surgical planning.

- Reinforce oral hygiene protocols to mitigate risk of secondary caries in restored teeth (#35, #33, #43).
- Monitor the suspicious area *near* #35 for radiographic progression or clinical symptoms.

- **Referral to oral surgeon** for evaluation of the suspected impacted area *near* #35.
 - **6-month recall** for radiographic reassessment of restorations (#35, #33, #43) and impacted lesion.
 - Schedule **endodontic consultation** for rc-treated tooth *near* #33 if asymptomatic and functionally stable.
-
