Grounding Caption

Medical Report

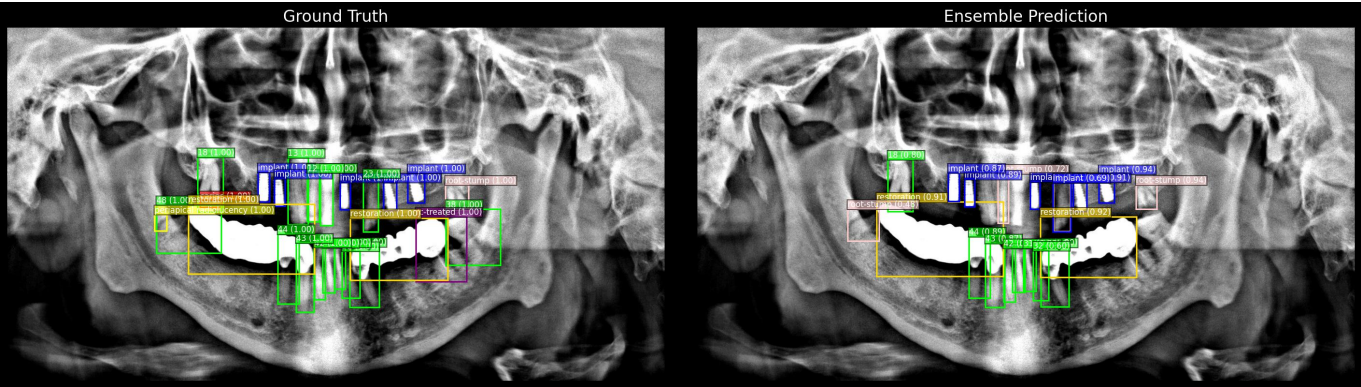
A total of 8 teeth are visualized, including mandibular molars (#33, #44, #41, #43, #42, #31, #18) and one maxillary molar (#32). The left mandibular first molar (#32) is partially visualized (confidence score: 0.6). Wisdom teeth analysis reveals #18 is fully erupted and not impacted, with no evidence of impaction.

- **#33**: Clear indication of a root stump near the distal aspect (confidence score: 0.94).
- **#44**: Suspicious for a root stump near the mesial aspect (confidence score: 0.72).
- **#18**: Areas of concern noted for a root stump near the apical region (confidence score: 0.48).
- **#33**: Additional suspicious area for a root stump near the distobuccal aspect (confidence score: 0.45).

- **#33**: Presence of a crown restoration and three implant fixtures (one apical, one mid-root, and one distal).
 - **#44**: Restoration observed near the mesial surface.
 - **#31**: Implant fixture detected near the mid-root.
 - **#18**: Two implant fixtures identified near the apical and mid-root regions.
-

- Root stumps near #33 (confirmed) and #44 (suspected) require evaluation for potential extraction or endodontic intervention.
- Suspicious root remnants near #18 and #33 necessitate further imaging (e.g., CBCT) to clarify extent.

- Reinforce meticulous oral hygiene around implant fixtures (#33, #31, #18) to prevent peri-implantitis.
- Monitor suspicious areas near #44 and #18 for progressive radiographic changes during routine recalls.

- Schedule a 3–6 month recall for clinical and radiographic reevaluation of root stumps.
- Refer to a periodontist or oral surgeon for definitive management of root stumps and implant stability assessment.
- Consider CBCT imaging for comprehensive evaluation of #33 and #18 pathology.
