## Grounding Caption

This localization caption provides multi-dimensional spatial analysis of anatomical structures and pathological findings for this panoramic dental X-ray image, including:

## Medical Report

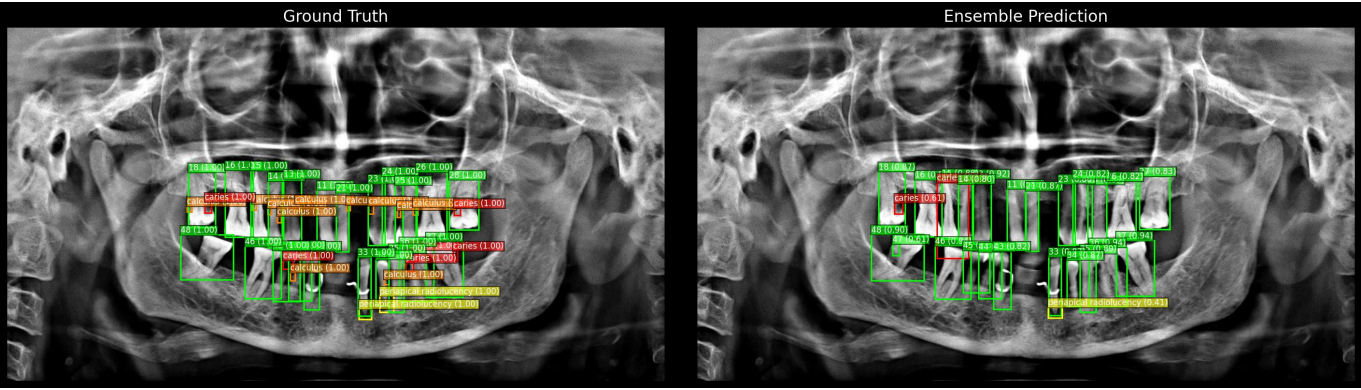
Teeth visibility with center points (total: 23):

Wisdom teeth detection (total: 2):

Dental Pathological Findings (total: 3):

```
[
{'box_2d': [634, 408, 717, 609], 'tooth_id': '15', 'label': 'caries', 'score': 0.18},
{'box_2d': [521, 462, 543, 492], 'tooth_id': 'unknown', 'label': 'caries', 'score': 0.61, 'near_tooth': '18'},
{'box_2d': [927, 738, 965, 767], 'tooth_id': 'unknown', 'label': 'periapical radiolucency', 'score': 0.41, 'near_tooth': '33'}
]
```

- A total of 23 teeth were visualized on the panoramic radiograph.
- Wisdom teeth (#48 and #18) are present and not impacted.

- **#15:** Suspicious for caries with radiographic evidence of a radiolucent lesion at the proximal surface.
- **Near #18:** Areas of concern noted for potential caries at the cervical region adjacent to the mandibular right third molar (#18).
- **Near #33:** Areas of concern observed for possible periapical radiolucency at the apical region adjacent to the maxillary left first molar (#33).

- No restorations, crowns, root canal treatments, or implants were identified in the current examination.
-

- **#15 (Mandibular Left Second Premolar):** Requires immediate evaluation for suspected caries; progression could compromise pulp vitality.
- **Near #18 and #33:** Monitor for progression of suspected caries and periapical pathology, which may indicate endodontic compromise.

- Reinforce patient education on interdental plaque control, particularly for areas adjacent to #18 and #33.
- Recommend dietary counseling to reduce caries risk.

- **6-month recall** for radiographic and clinical reassessment of #15, #18, and #33.
- **Referral to endodontist** if periapical radiolucency near #33 persists or worsens.
- Consider intraoral imaging (e.g., bitewing) for definitive diagnosis of carious lesions.
