Grounding Caption

This localization caption provides multi-dimensional spatial analysis of anatomical structures and pathological findings for this panoramic dental X-ray image, including:

Medical Report

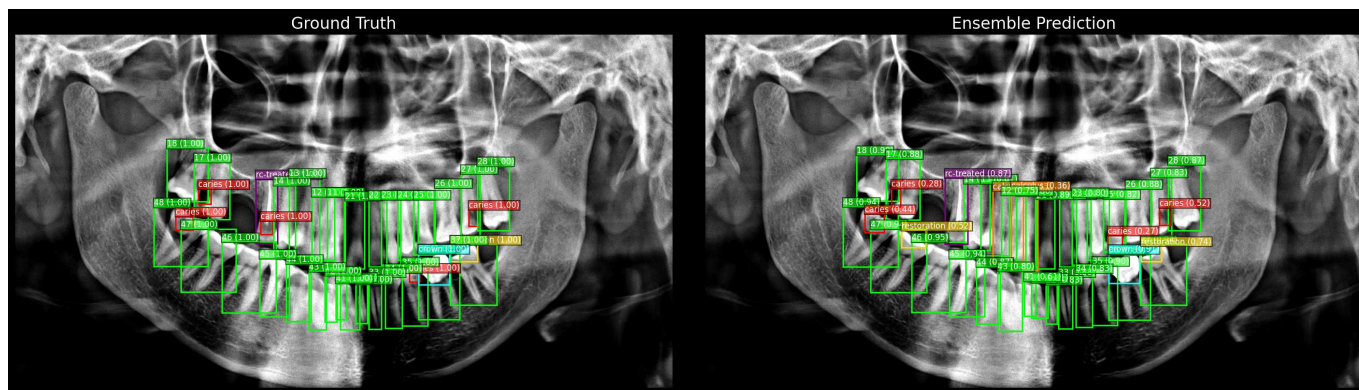
Teeth visibility with center points (total: 28):

Wisdom teeth detection (total: 3):

Dental Pathological Findings (total: 6):

```
[
{'box_2d': [761, 412, 841, 601], 'tooth_id': '13', 'label': 'calculus', 'score': 0.43},
{'box_2d': [808, 411, 879, 625], 'tooth_id': '11', 'label': 'calculus', 'score': 0.36},
{'box_2d': [1202, 457, 1232, 503], 'tooth_id': 'unknown', 'label': 'caries', 'score': 0.52, 'near_tooth': '27'},
{'box_2d': [421, 473, 472, 522], 'tooth_id': 'unknown', 'label': 'caries', 'score': 0.44, 'near_tooth': '48'},
{'box_2d': [492, 406, 516, 455], 'tooth_id': 'unknown', 'label': 'caries', 'score': 0.28, 'near_tooth': '17'},
{'box_2d': [1065, 530, 1103, 566], 'tooth_id': 'unknown', 'label': 'caries', 'score': 0.27, 'near_tooth': '25'}
]
```

Historical Treatments (total: 4):

```
[
  {'box_2d': [1067, 578, 1149, 656], 'tooth_id': '36', 'label': 'crown', 'score': 0.91},
```

```
{'box_2d': [634, 378, 693, 552], 'tooth_id': 'unknown', 'label': 'rc-treated', 'score': 0.87, 'near_tooth': '14'},
{'box_2d': [1153, 558, 1206, 599], 'tooth_id': 'unknown', 'label': 'restoration', 'score': 0.74, 'near_tooth': '37'},
{'box_2d': [518, 516, 583, 562], 'tooth_id': 'unknown', 'label': 'restoration', 'score': 0.52, 'near_tooth': '47'}
]
```

- A total of 28 teeth are visualized, including all permanent teeth.
- Wisdom teeth (#48, #18, #28) are present and non-impacted. No signs of impaction or pathologic displacement observed.

- **#13**: Suspected calculus deposition noted on the root surface.
- **#11**: Areas of concern for calculus accumulation on the occlusal aspect.
- **Near #27**: Suspicious for early carious lesion on the mesial surface.
- **Near #48**: Suggestive of a small carious radiolucency near the distal cervical region.
- **Near #17**: Areas of concern for potential caries on the proximal contact.
- **Near #25**: Suggestive of a carious-like radiolucency near the mid-root area.

- **#36**: Presence of a full-coverage crown.
 - **Near #14**: Evidence of root canal treatment.
 - **Near #37**: Restorative material on the distal surface.
 - **Near #47**: Residual restoration on the mesial aspect.
-

- **#13 and #11**: Suspected calculus deposits require professional scaling and improved interdental hygiene.
- **Proximal caries near #27 and #48**: Monitor for progression; consider radiographic correlation.
- **#37 and #47**: Evaluate restoration integrity for secondary caries or marginal breakdown.

- Reinforce interdental cleaning techniques (flossing, interproximal brushes) to address calculus-prone areas (#13, #11).
- Counsel on dietary modifications to reduce caries risk in suspicious regions (near #27, #48, #17, #25).
- Schedule regular radiographic follow-ups to assess suspicious carious lesions.

- **6-month recall** for periodontal evaluation and re-evaluation of questionable caries.
 - **Referral to endodontist** for #14 if asymptomatic but root canal-treated status shows radiographic compromise.
 - **Dental caries risk assessment** for prioritized teeth (near #27, #48) with targeted remineralization therapy.
-
