## Grounding Caption

This localization caption provides multi-dimensional spatial analysis of anatomical structures and pathological findings for this panoramic dental X-ray image, including:

## Medical Report

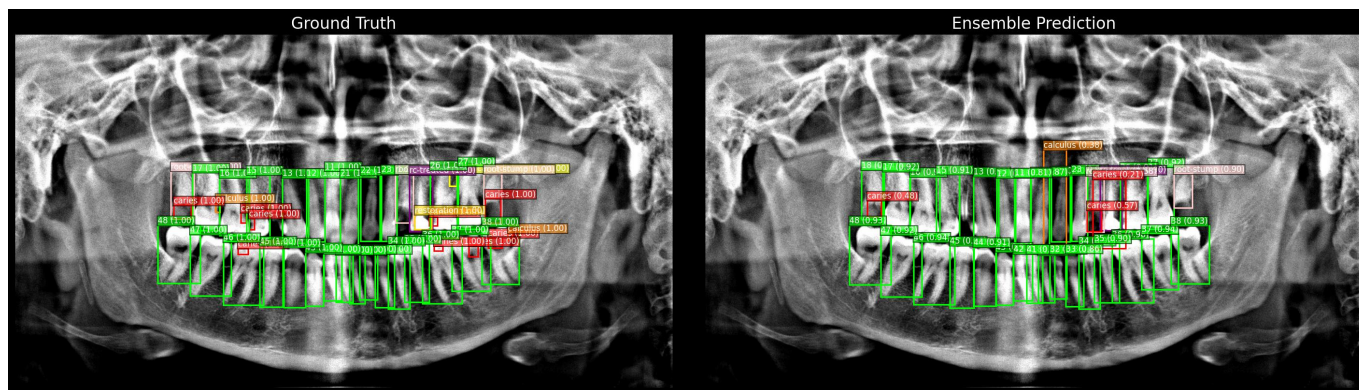
A total of 28 teeth are visualized with clear localization. All three identified wisdom teeth (#18, #38, #48) are fully erupted and not impacted. No evidence of periodontal bone loss or extensive tooth loss is observed.

- #22: Evidence of calculus deposition on the cervical region.
- Near #27: Clear indication of a root stump in the apical region.
- Near #23: Suspicious for a root stump and suspicious for caries on the distal aspect.
- Near #18: Suspected caries on the mesial surface.
- Near #26: Areas of concern noted for caries on the distal aspect.

- Near #26: RC-treated tooth confirmed with a well-defined apical radiolucency.
-

- Confirmed root stump near #27 requires evaluation for potential extraction or surgical intervention.
- Suspicious root stump and caries near #23 necessitate further diagnostic assessment (e.g., CBCT) to determine treatability.
- RC-treated tooth on #26 should be monitored for apical healing and signs of reinfection.

- Reinforce oral hygiene protocols for #22 to manage calculus accumulation.
- Address potential caries near #18 and #26 with fluoride application and dietary counseling.
- Educate on interproximal cleaning for #23 to mitigate caries progression.

- Schedule a 6-month recall for monitoring pathological findings near #23, #26, and #27.
- Urgent referral to an endodontist for #26 to assess apical pathology.
- Consider surgical consultation for root stumps near #23 and #27 based on CBCT findings.
