## Grounding Caption

# Medical Report

## Oral Panoramic Examination Report

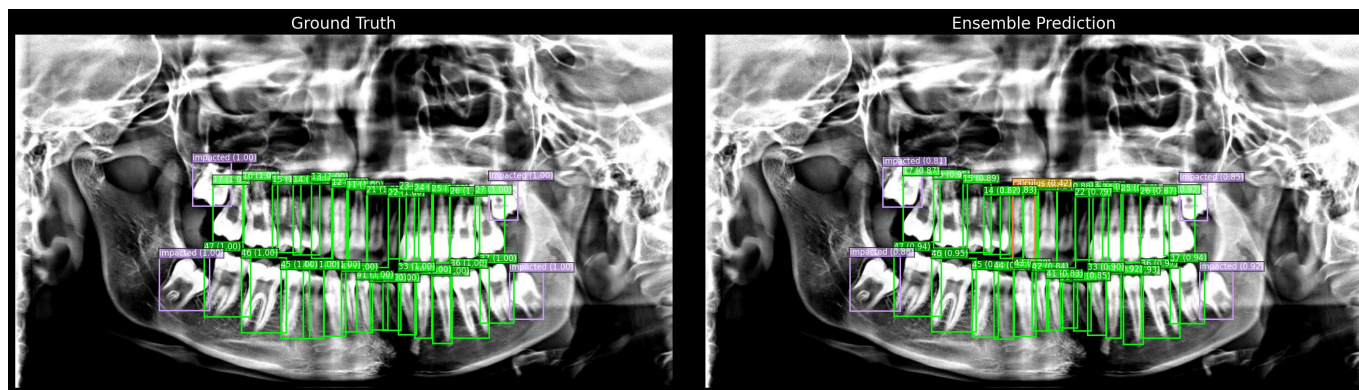
This localization caption provides multi-dimensional spatial analysis of anatomical structures and pathological findings for this panoramic dental X-ray image, including:

```
[
{'box_2d': [813, 403, 871, 600], 'tooth_id': '12', 'label': 'calculus', 'score': 0.42},
{'box_2d': [1307, 623, 1395, 751], 'tooth_id': 'unknown', 'label': 'impacted', 'score': 0.92, 'near_tooth': '37'},
{'box_2d': [382, 585, 514, 729], 'tooth_id': 'unknown', 'label': 'impacted', 'score': 0.88, 'near_tooth': '47'},
{'box_2d': [1255, 388, 1328, 491], 'tooth_id': 'unknown', 'label': 'impacted', 'score': 0.85, 'near_tooth': '27'},
{'box_2d': [469, 345, 572, 454], 'tooth_id': 'unknown', 'label': 'impacted', 'score': 0.81, 'near_tooth': '17'}
]
```

A total of 28 teeth were visualized within the panoramic field. All permanent teeth are present and anatomically identifiable. No wisdom teeth (third molars) were detected.

- Tooth #12 (Upper Right Lateral Incisor):** Suspicious for periodontal calculus deposition, as subtle radiopaque accumulations are noted in the apical region.
- Near Tooth #37 (Lower Left Second Molar):** Shows evidence of an impacted anatomical structure, likely a retained developmental cyst or bony impaction.
- Near Tooth #47 (Lower Right Second Molar):** Clear indication of an impacted entity adjacent to the apical region, consistent with a radiolucent defect or cystic formation.
- Near Tooth #27 (Upper Left Second Molar):** Radiographic evidence of a bony impaction along the distal root surface.
- Near Tooth #17 (Upper Right Second Molar):** Impacted lesion identified near the apical region, suggestive of a resorptive or cystic process.

No restorations, root canal treatments, crowns, or implants were identified in the visualized field.

- Impacted structures near multiple molars:** Radiolucent or radiopaque lesions near teeth #37, #47, #27, and #17 require further diagnostic evaluation (e.g., CBCT imaging) to determine etiology and surgical intervention needs.
- Calculus suspicion on #12:** Suspected subgingival calculus at #12 warrants scaling and root planing to mitigate periodontal risk.

- Reinforce meticulous oral hygiene protocols, emphasizing interdental cleaning for impacted regions.
- Monitor areas of suspected calculus with follow-up radiographs in 3–6 months.

- **Referral:** Urgent consultation with an oral surgeon or endodontist for evaluation of impacted lesions near molars (#37, #47, #27, #17).
  - **Recall:** Schedule a 6-month follow-up to reassess calculus management and track changes in impacted regions.
  - **Patient Education:** Advise against self-manipulation of impacted areas and emphasize compliance with hygiene regimens.
-
