Grounding Caption

Medical Report

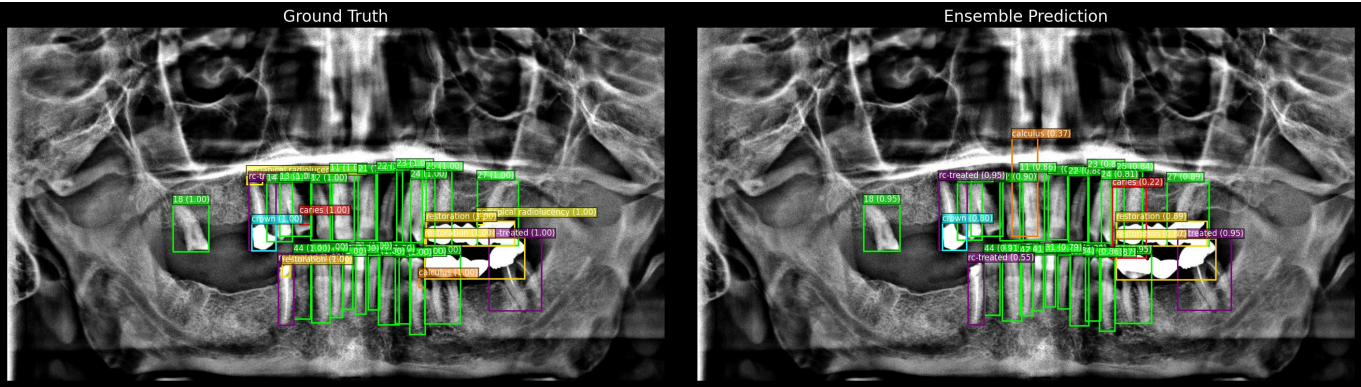
This localization caption provides multi-dimensional spatial analysis of anatomical structures and pathological findings for this panoramic dental X-ray image, including:

Teeth visibility with center points (total: 21):

Wisdom teeth detection (total: 1):

Dental Pathological Findings (total: 2):

```
[
{'box_2d': [832, 291, 899, 550], 'tooth_id': '11', 'label': 'calculus', 'score': 0.37},
{'box_2d': [1098, 419, 1188, 608], 'tooth_id': '25', 'label': 'caries', 'score': 0.22}
]
```

Historical Treatments (total: 6):

```
[
{'box_2d': [1271, 555, 1412, 745], 'tooth_id': 'unknown', 'label': 'rc-treated', 'score': 0.95, 'near_tooth': '27'},
{'box_2d': [639, 401, 712, 587], 'tooth_id': 'unknown', 'label': 'rc-treated', 'score': 0.95, 'near_tooth': '14'},
{'box_2d': [1108, 510, 1348, 575], 'tooth_id': 'unknown', 'label': 'restoration', 'score': 0.89, 'near_tooth': '27'},
{'box_2d': [1108, 556, 1371, 665], 'tooth_id': 'unknown', 'label': 'restoration', 'score': 0.87, 'near_tooth': '36'},
{'box_2d': [648, 515, 711, 587], 'tooth_id': 'unknown', 'label': 'crown', 'score': 0.8, 'near_tooth': '14'},
{'box_2d': [716, 618, 758, 784], 'tooth_id': 'unknown', 'label': 'rc-treated', 'score': 0.55, 'near_tooth': '44'}
]
```

A total of 21 teeth were visualized within the panoramic image. The maxillary left first molar (#18) is present and unimpacted. Remaining dentition appears structurally intact with no overt signs of mobility or gross anatomical abnormalities.

- **Tooth #11 (maxillary right lateral incisor):** Suspicious for **calculus deposition** noted in the apical region.
- **Tooth #25 (mandibular right first molar):** Areas of concern for **incipient carious lesion** in the mesial aspect.

- **Tooth #14 (mandibular left first premolar):** Presence of **crown** and **root canal-treated (rc-treated) canal**.
 - **Tooth #27 (mandibular right second molar):** Evidence of **root canal therapy** and two distinct **restorations** in the distal and mesial regions.
 - **Tooth #36 (maxillary right first molar):** A **restoration** is observed in the distal surface.
 - **Near tooth #44 (maxillary left first premolar):** A **root canal-treated canal** is identified; further verification recommended due to low confidence in detection.
-

- Monitor suspicious calculus on #11 for potential progression to subgingival deposits.
- Address suspected caries on #25 with early intervention to prevent pulp involvement.
- Confirm presence of root canal-treated canal near #44 via supplemental imaging or clinical correlation.

- Reinforce oral hygiene protocols, emphasizing interdental cleaning for #11 and #25.
- Schedule periodontal assessment to evaluate calculus in #11 and recommend prophylactic scaling if needed.

- **6-month recall** to reassess caries on #25 and monitor calculus on #11.
- **Referral to endodontist** for evaluation of root canal-treated canal near #44.
- Consider **restorative intervention** for #25 if caries progression is confirmed.
