Grounding Caption

This localization caption provides multi-dimensional spatial analysis of anatomical structures and pathological findings for this panoramic dental X-ray image, including:

Medical Report

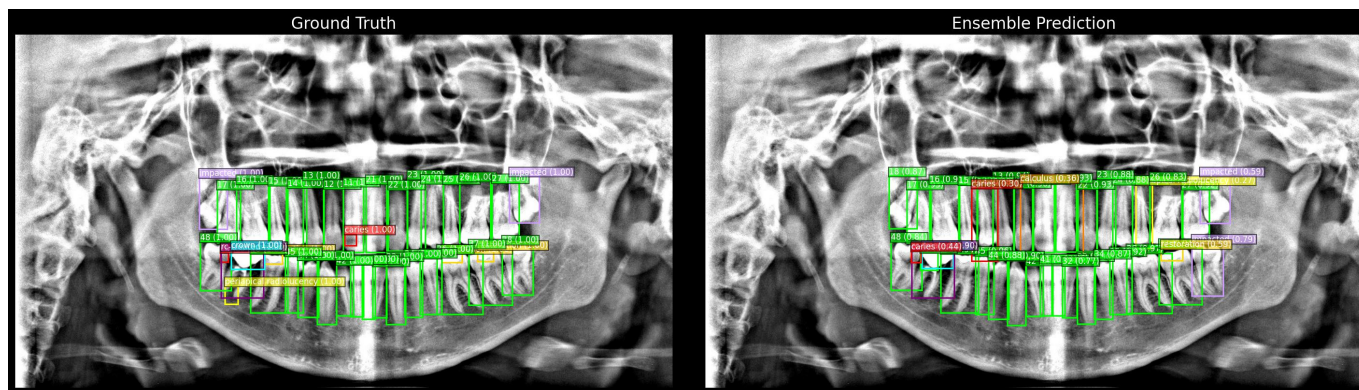
A total of 30 teeth are visualized within the panoramic field of view. All identified wisdom teeth (#18 and #48) are fully erupted and not impacted. The remaining dentition demonstrates normal morphology and spatial alignment.

- #14: Suspicious for early carious lesion in the mesial aspect.
- #11: Suspicious for calculus deposition in the subgingival region.
- #25: Areas of concern noted for periapical radiolucency at the apical region.
- Near #37: Suspicious for impacted tooth in the posterior mandibular region.
- Near #27: Suspicious for impacted tooth in the posterior mandibular region.
- Near #48: Suspicious for carious lesion in the distal aspect of the adjacent soft tissues.

- #47: Presence of a crown on the mesiobuccal surface.
- Near #47: Root canal-treated tooth with radiopaque filling visible.
- Near #37: Presence of a restoration in the interproximal area.

- Suspicious impacted tooth near #37 and #27 requires further radiographic and clinical evaluation to assess surgical extraction feasibility.
- Periapical radiolucency at #25 necessitates endodontic assessment to rule out apical periodontitis or non-vitality.
- Carious lesion near #48 should be confirmed via close-up imaging and addressed with preventive or restorative intervention.

- Reinforce oral hygiene measures, particularly for areas with calculus susceptibility (#11).
- Monitor suspicious caries (#14) and impacted teeth (#37, #27) for progression during routine recalls.

- Refer to an endodontist for definitive management of #25's apical radiolucency.
- Schedule a 6-month recall for reassessment of impacted teeth and calculus-prone regions.
- Consider cone-beam CT imaging for detailed evaluation of impacted mandibular teeth (#37, #27).
