## Grounding Caption

# Medical Report

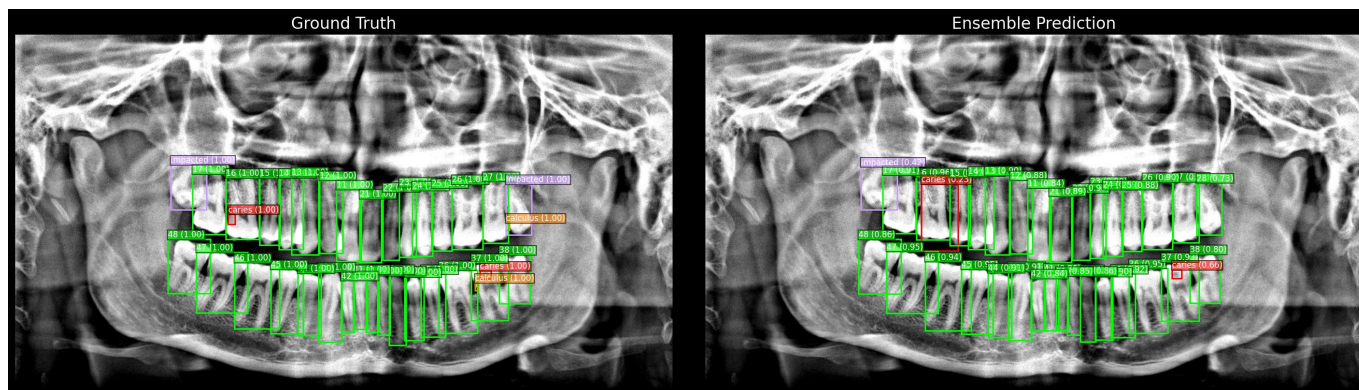
This localization caption provides multi-dimensional spatial analysis of anatomical structures and pathological findings for this panoramic dental X-ray image, including:

Teeth visibility with center points (total: 31):

Wisdom teeth detection (total: 3):

Dental Pathological Findings (total: 3):

```
[
{'box_2d': [571, 394, 668, 570], 'tooth_id': '16', 'label': 'caries', 'score': 0.23},
{'box_2d': [1234, 620, 1260, 643], 'tooth_id': 'unknown', 'label': 'caries', 'score': 0.66, 'near_tooth': '37'},
{'box_2d': [411, 348, 507, 462], 'tooth_id': 'unknown', 'label': 'impacted', 'score': 0.42, 'near_tooth': '17'}
]
```

A total of 31 teeth are visualized. All three identified wisdom teeth (#28, #38, #48) are present and not impacted. The overall dental arch alignment appears unremarkable.

- #16 (upper right first molar): Suspicious for caries.
- Near #37 (lower left first molar): An area suspicious for caries is observed.
- Near #17 (upper right second molar): A suspicious region suggestive of an impacted tooth or structural anomaly is noted.

No prior restorations, crowns, root canal treatments, or implants are observed.

- Suspected caries on #16 (upper right first molar) and near #37 (lower left first molar).
- Anomalous area near #17 (upper right second molar) warrants evaluation to clarify the nature of the suspicious finding.

- Reinforce oral hygiene practices, emphasizing interdental cleaning for caries-prone areas.
- Monitor questionable regions for progression, particularly near #37 and #17.

- Schedule a clinical examination within 2 weeks to confirm caries on #16 and near #37.
- Referral to an oral surgeon is recommended for further assessment of the suspicious area near #17.
- 6-month recall for radiographic reassessment and preventive care reinforcement.
