Medical Report

Oral Panoramic X-ray Examination Report

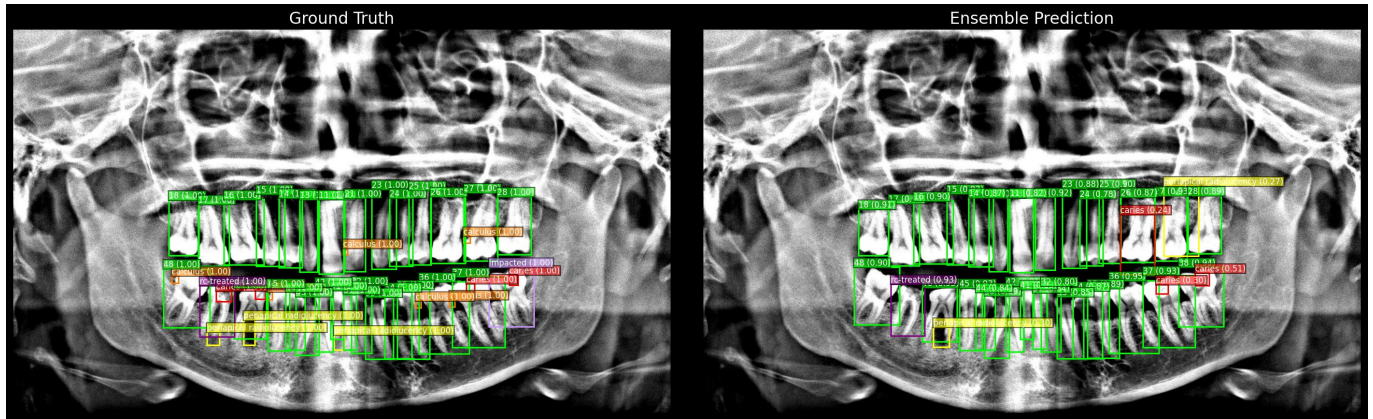
A total of 29 teeth were visualized using the FDI numbering system. All four wisdom teeth (#18, #28, #38, #48) were present and erupted without evidence of impaction.

- **Tooth #27**: Areas of concern noted for **periapical radiolucency** at the apical region.
- **Tooth #26**: Suspicious for **caries** on the mesiobuccal surface.
- **Near tooth #38**: Areas of concern noted for **caries** on the distal surface.
- **Near tooth #37**: Suspicious for **caries** on the mesial surface.
- **Near tooth #46**: Areas of concern noted for **periapical radiolucency** adjacent to the apical region.

- **Near tooth #46**: Presence of a **root canal-treated** tooth with radiolucent changes in the apical region.
-

- Suspicious **caries** near tooth #38 and #37 require clinical correlation and possible restorative intervention.
- **Periapical radiolucency** near tooth #46 (associated with a root canal-treated tooth) warrants further evaluation for apical pathology.
- **Tooth #27** and **#26** demonstrate areas of concern requiring close monitoring for progressive caries or endodontic involvement.

- Reinforce oral hygiene measures, particularly around teeth #37, #38, and #46.
- Monitor suspicious caries near #37, #38, and #26 for progression.

- **6-month recall** for radiographic and clinical reassessment of suspicious lesions.
 - Referral to an **endodontist** for evaluation of apical radiolucency near #46 and suspected caries on #26.
 - Consider **restorative intervention** for caries near #37 and #38 after definitive diagnosis.
-
