Grounding Caption

This localization caption provides multi-dimensional spatial analysis of anatomical structures and pathological findings for this panoramic dental X-ray image, including:

Medical Report

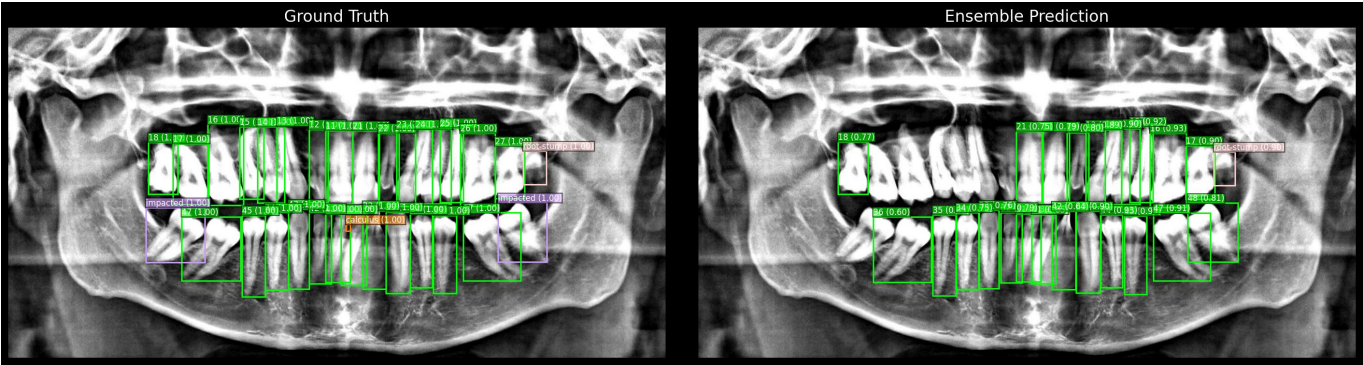
A total of 22 teeth are visualized in the panoramic radiograph. Wisdom teeth (#18 and #48) are present with no evidence of impaction. The overall dental arch demonstrates adequate alignment and eruption.

A residual root fragment is identified adjacent to the apical region of tooth #17, suggesting prior partial resorption or incomplete extraction. This finding shows clear radiographic evidence of a non-vital root remnant with no associated periapical pathology.

- Residual root fragment detected near tooth #17 requires evaluation for potential extraction or monitoring.

- Reinforce meticulous plaque control adjacent to #17 to prevent caries or periodontal complications.
- Continue regular oral hygiene education to maintain periodontal health.

- Referral to an oral surgeon for assessment of the residual root fragment (#17) to determine clinical significance.
- Schedule a 6-month recall with panoramic imaging to monitor for changes in the residual fragment or adjacent structures.
- Proceed with targeted clinical examination to rule for asymptomatic retention or infection.
