This localization caption provides multi-dimensional spatial analysis of anatomical structures and pathological findings for this panoramic dental X-ray image, including:

### Oral Panoramic X-Ray Report

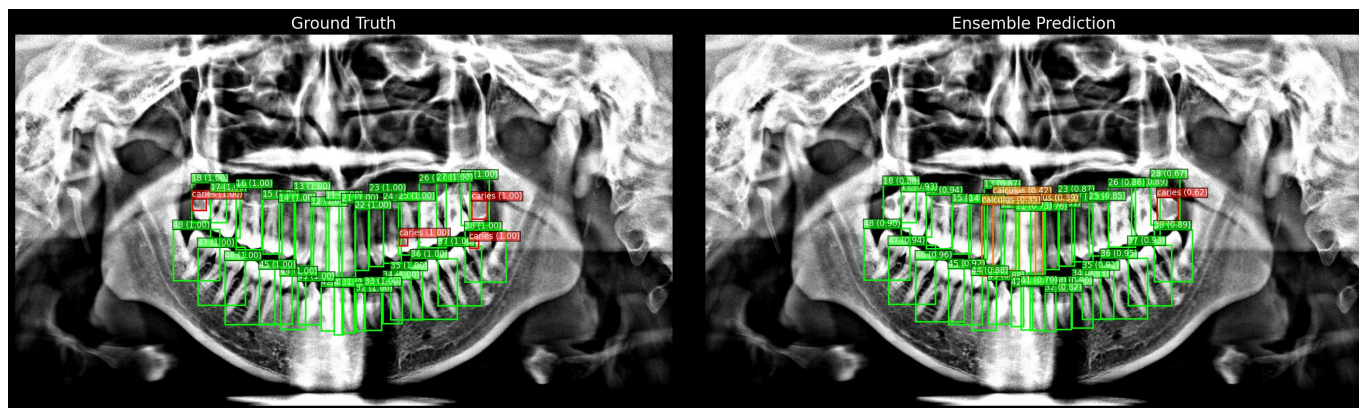
A total of 32 teeth are visualized, with all four wisdom teeth (#18, #28, #38, and #48) present and unimpacted. The dentition demonstrates adequate alignment and spatial distribution. No evidence of recent dental trauma or fractures is noted.

- Areas of concern noted for **calculus** on teeth #13 and #21.
- **Suspicious for calculus** near tooth #12.
- **Suspicious for carious lesion** on tooth #28.

No prior restorations, crowns, root canal treatments, or implants are observed in the current examination.

1. **Suspicious caries** on tooth #28 (upper right third molar) warrants immediate clinical evaluation to confirm diagnosis and prevent progression.
2. **Areas of suspected calculus** on teeth #13, #21, and near tooth #12 require professional debridement and monitoring.

- Reinforce patient education on plaque control techniques and interdental cleaning for calculus-prone regions.
- Emphasize fluoride use and dietary counseling to mitigate caries risk in #28.

- Schedule **3-month recall** for reassessment of calculus deposits and caries confirmation via re-examination and, if necessary, supplemental imaging.
  - Proceed with **professional scaling** for calculus removal in the identified areas.
  - Refer for **endodontic consultation** if caries on #28 progresses to pulp involvement.
-
