Grounding Caption

This localization caption provides multi-dimensional spatial analysis of anatomical structures and pathological findings for this panoramic dental X-ray image, including:

Medical Report

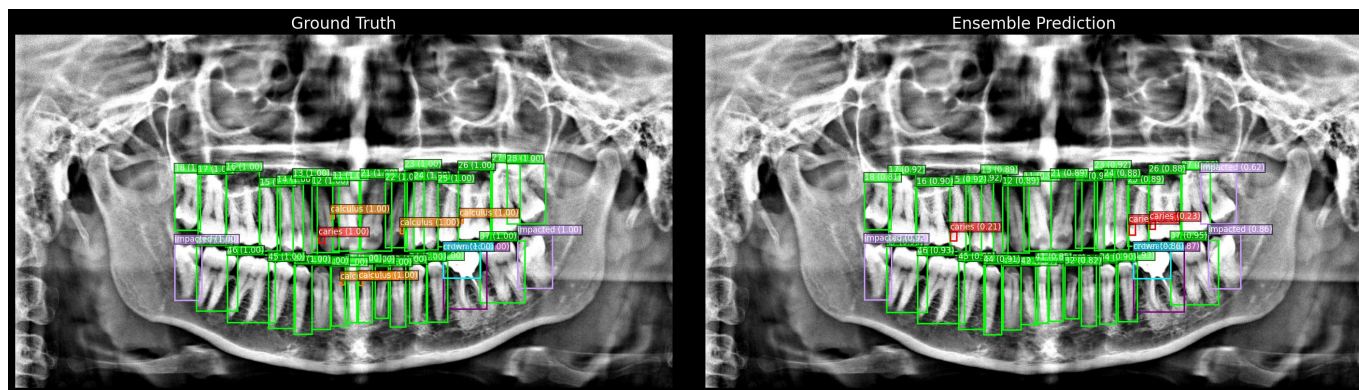
A total of 28 teeth are visualized, with all primary dentition structures intact. Wisdom teeth status reveals that #18 is present and unimpacted, while the remaining wisdom teeth (17, 28, 37) are not visualized in the field of view.

- **Tooth #47:** A clear indication of an impacted tooth is noted near the distal aspect of #47.
- **Tooth #37:** A sign of an impacted tooth is observed adjacent to #37.
- **Tooth #27:** Suspicious for an impacted tooth near the apical region of #27.
- **Tooth #25:** Areas of concern noted for potential carious lesions near the mesial surface of #25.
- **Tooth #15:** Suspicious for carious involvement near the distal surface of #15.

- **Tooth #35:** Presence of a crown and root canal-treated tooth confirmed.
-

1. Impacted tooth near #47 and #37 requiring evaluation for surgical extraction.
2. Suspicious carious lesions near #25 and #15 necessitating further diagnostic imaging (e.g., bitewing radiographs).

- Reinforce oral hygiene protocols, emphasizing interproximal cleaning for high-risk areas (#15, #25).
- Monitor suspicious zones near #27 for progression of potential impaction.

- **Referral to oral surgeon:** Immediate assessment for impacted teeth near #37 and #47 to determine surgical feasibility.
- **3-month recall:** Monitor carious areas near #25 and #15, with re-evaluation of radiographic findings.
- **Dental hygiene appointment:** Schedule professional cleaning to address potential calculus buildup in the posterior mandible.
