## Grounding Caption

## Medical Report

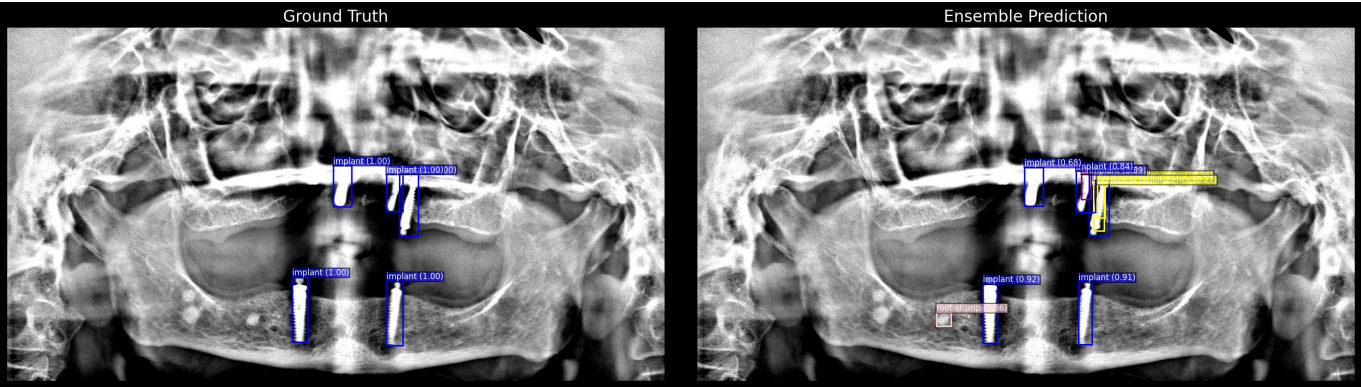
[  
{'box\_2d': [633, 752, 670, 788], 'tooth\_id': 'unknown', 'label': 'root-stump', 'score': 0.66},  
{'box\_2d': [1048, 402, 1076, 536], 'tooth\_id': 'unknown', 'label': 'periapical radiolucency', 'score': 0.36},  
{'box\_2d': [1058, 413, 1079, 501], 'tooth\_id': 'unknown', 'label': 'periapical radiolucency', 'score': 0.27}  
]

[  
{'box\_2d': [1016, 386, 1042, 453], 'tooth\_id': 'unknown', 'label': 'rc-treated', 'score': 0.56},  
{'box\_2d': [755, 677, 793, 833], 'tooth\_id': 'unknown', 'label': 'implant', 'score': 0.92},  
{'box\_2d': [1008, 671, 1045, 836], 'tooth\_id': 'unknown', 'label': 'implant', 'score': 0.91},  
{'box\_2d': [1037, 388, 1089, 549], 'tooth\_id': 'unknown', 'label': 'implant', 'score': 0.89},  
{'box\_2d': [1002, 378, 1053, 487], 'tooth\_id': 'unknown', 'label': 'implant', 'score': 0.84},  
{'box\_2d': [864, 368, 914, 471], 'tooth\_id': 'unknown', 'label': 'implant', 'score': 0.68}  
]

- No visualized teeth are identified in the panoramic image.
- Wisdom teeth are not detected, with no evidence of impaction or residual roots.

- A **suspicious root stump** is observed in the mandibular region, likely adjacent to implant sites.
- **Areas of concern for periapical radiolucency** are noted near the left posterior implant cluster, suggesting potential inflammatory or apical pathology.

- **Implants** are present in the left posterior mandible (#45, #46) and maxilla (#16), with definitive placement confirmed for high-confidence implants (scores  $\geq 0.85$ ).

- A **suspicious root canal-treated tooth** is identified near the maxillary left quadrant, though the corresponding tooth structure is not visualized.

- **Unaddressed periapical radiolucencies near #45 and #46** require further evaluation to rule out infection or implant-related complications.
- **Root stumps** adjacent to implants may necessitate surgical removal to prevent future complications.

- Reinforce meticulous oral hygiene protocols to mitigate biofilm accumulation around implant sites.
- Monitor root stumps for signs of resorption or infection during routine check-ups.

- **Referral to a periodontist** for assessment of periapical radiolucencies and implant stability.
  - **Surgical consultation** for root stumps if adjacent to functional implants.
  - **6-month recall** with panoramic imaging to track changes in pathological areas.
-
