Grounding Caption

Medical Report

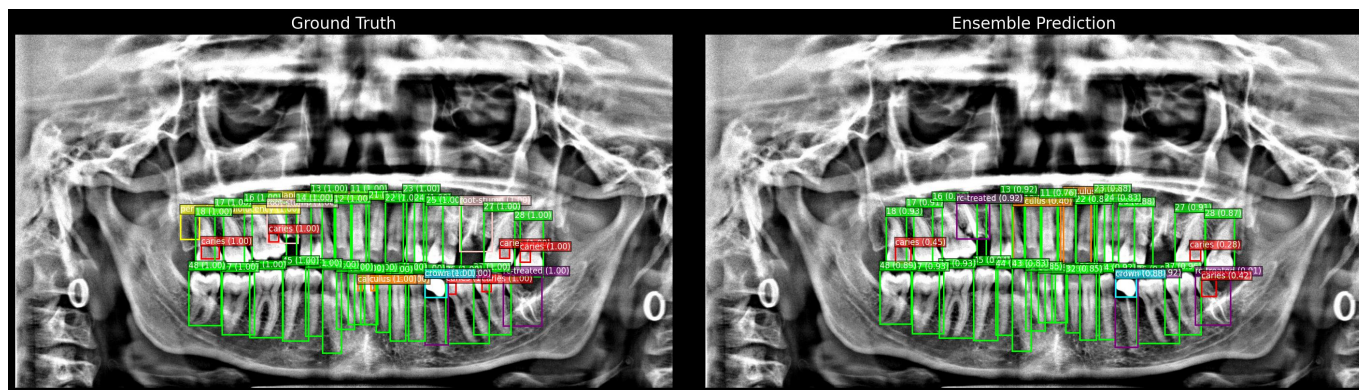
A total of 28 teeth are visualized, with most anatomical landmarks detectable. All visualized teeth demonstrate normal anatomical orientation. Wisdom teeth (#18, #28, and #48) are fully erupted and non-impacted. Tooth #11 (FDI #11) is not clearly visualized, suggesting potential underdevelopment or poor image clarity.

- Suspicious for carious lesions near #18, #37, and #27, with areas of radiolucency noted in proximity to these teeth.
- Suspicious for calculus deposits on #12 and #21, with localized radiopaque accumulations observed.

- Root canal-treated teeth identified near #16, #34, and #37, with visible post-treatment restorations.
 - A crown restoration is present on #34, with radiographic evidence of a metallic radiopacity.
-

- Areas of suspicious caries near #18, #37, and #27 require immediate evaluation for potential restoration or caries management.
- Suspected calculus deposits on #12 and #21 should be prioritized for professional scaling and polishing.

- Reinforce biofilm control measures (e.g., interdental brushing, flossing) around #12, #21, #18, #37, and #27 to mitigate further carious or plaque-related progression.
- Educate on dietary modifications to reduce cariogenic risk in high-risk areas.

- Schedule a 6-month recall for re-evaluation of suspected calculus and caries, including re-imaging if necessary.
- Referral to a general dentist for confirmation of carious lesions near #18, #37, and #27.
- Monitor #11 for developmental anomalies or missing tooth etiology during routine visits.
