Grounding Caption

Medical Report

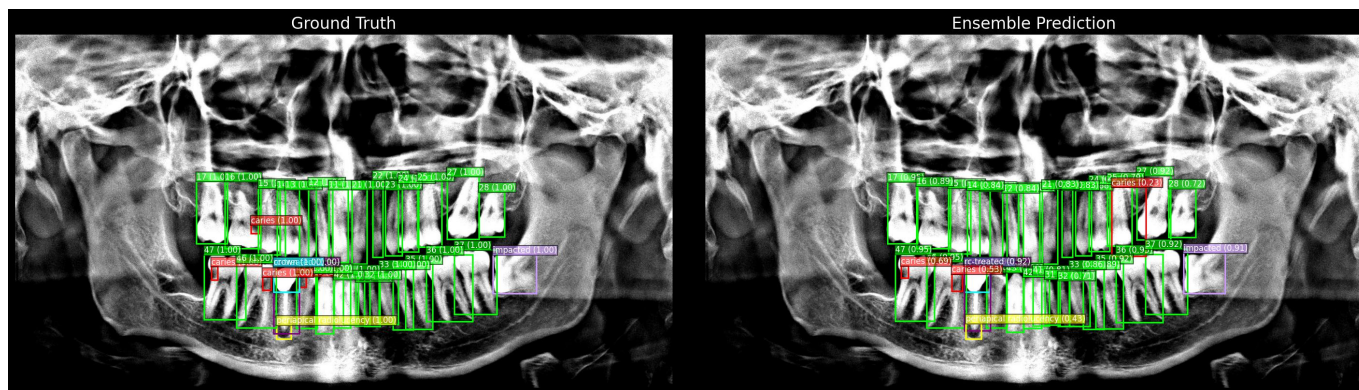
A total of 27 teeth are visualized, with the panoramic image demonstrating adequate clarity for diagnostic interpretation. The wisdom tooth (#28) is present and unimpacted, consistent with normal eruption. No evidence of agenesis or supernumerary teeth is noted.

- #25 (lower left first molar): Suspicious for caries involving the occlusal surface.
- Near #37 (lower left first molar): Clear indication of an impacted structure adjacent to the distal aspect.
- Near #47 (lower right second molar): Suspicion of caries localized to the mesial surface.
- Near #46 (lower right first molar): Areas of concern for caries on the distal surface.
- Near #44 (lower right first molar): Suspicious for periapical radiolucency suggesting potential apical pathology.

- #44 (lower right first molar): Presence of a crown and evidence of root canal treatment.
-

- Impacted structure near #37 requires further evaluation to assess for resorption of adjacent teeth or periodontal compromise.
- Suspicious caries on #25 and near #47 necessitates prompt diagnostic confirmation (e.g., intraoral radiograph) to determine caries depth.
- Periapical radiolucency near #44 should be evaluated for apical granuloma or residual infection despite prior root canal treatment.

- Reinforce oral hygiene protocols, emphasizing interproximal plaque control near #25, #46, and #47.
- Monitor suspicious carious lesions for progression during follow-up visits.

- Schedule a 6-month recall for reassessment of #25, #46, #47, and #44.
- Referral to an endodontist is recommended for #44 to evaluate apical pathology and determine need for retreatment.
- If impacted structure near #37 is confirmed, surgical consultation should be considered to plan for potential extraction.
