Grounding Caption

This localization caption provides multi-dimensional spatial analysis of anatomical structures and pathological findings for this panoramic dental X-ray image, including:

Medical Report

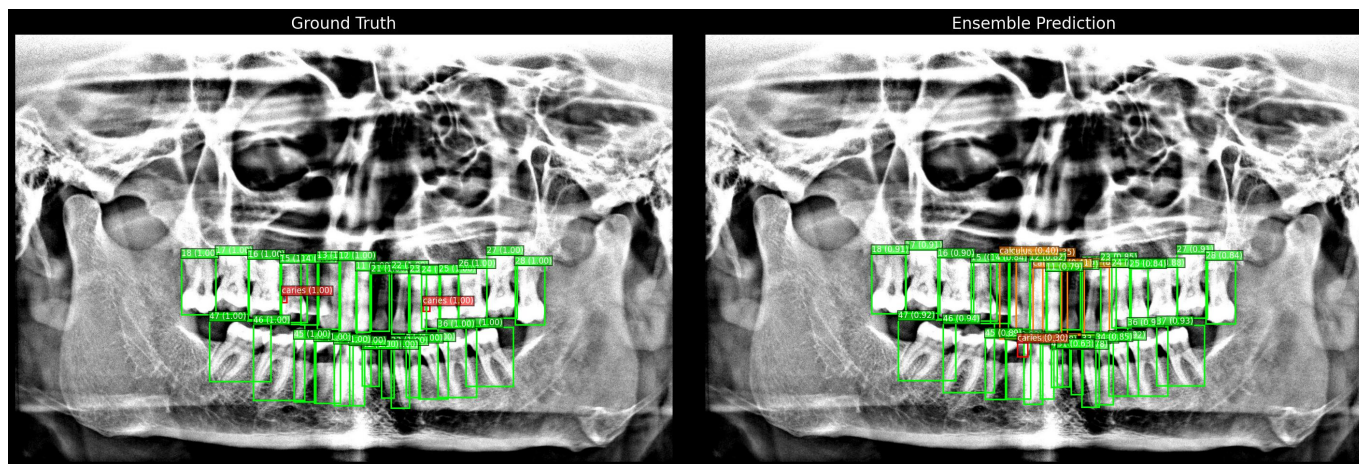
A total of 30 teeth are visualized. All wisdom teeth (#18 and #28) are present and unimpacted. The remaining teeth show no evidence of gross anatomical abnormalities or resorption.

- Suspicious for calculus deposition on #13, #21, and #22.
- Areas of concern noted for potential calculus near tooth #12.
- Suspicious for early carious lesion near tooth #44 (adjacent to #44).

No prior restorations, crowns, root canal treatments, or implants are observed.

- Suspicious calculus deposits on #13, #21, and #22, as well as near #12.
- Early suspicious carious lesion near #44 requires further evaluation.

- Reinforce oral hygiene instruction, emphasizing interproximal cleaning for calculus-prone areas.
- Monitor suspicious carious lesion near #44 for progression.

- Schedule a 6-month recall for professional scaling and re-evaluation of calculus deposits.
- Consider referral to a restorative specialist if caries near #44 progresses.
- Continue routine panoramic imaging for longitudinal assessment of high-risk areas.
