## Grounding Caption

# Medical Report

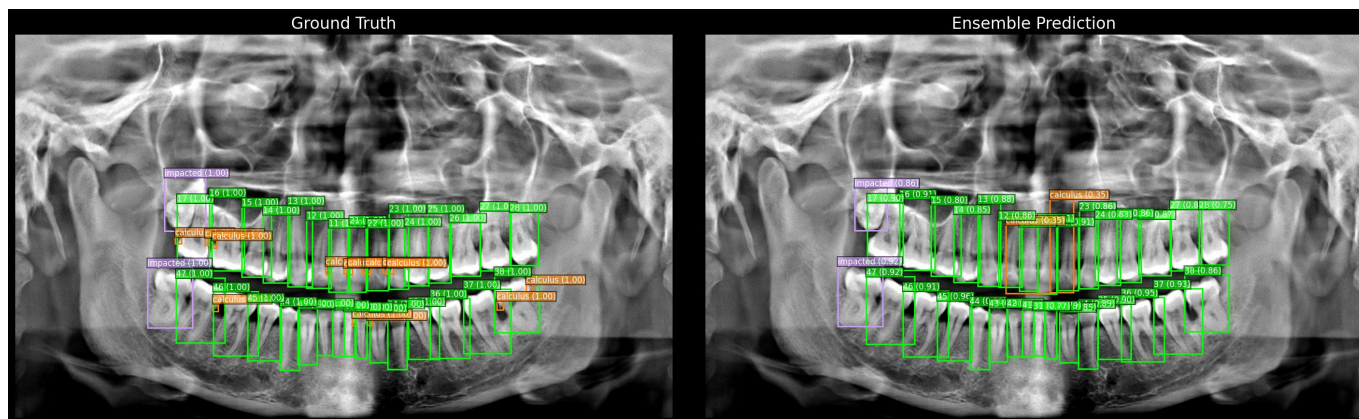
Teeth visibility with center points (total: 30):

Dental Pathological Findings (total: 4):

```
[
{'box_2d': [887, 423, 949, 664], 'tooth_id': '22', 'label': 'calculus', 'score': 0.35},
{'box_2d': [775, 490, 888, 666], 'tooth_id': '11', 'label': 'calculus', 'score': 0.35},
{'box_2d': [341, 596, 456, 751], 'tooth_id': 'unknown', 'label': 'impacted', 'score': 0.92, 'near_tooth': '47'},
{'box_2d': [384, 394, 467, 505], 'tooth_id': 'unknown', 'label': 'impacted', 'score': 0.86, 'near_tooth': '17'}
]
```

A total of 30 teeth were visualized on the panoramic radiograph, with no evidence of supernumerary or missing teeth. The bilateral lower wisdom teeth (#28 and #38) are present and not impacted. No radiographic signs of caries or fractures were observed in the remaining dentition.

- **Caries:** No radiographic evidence of cariogenic lesions was detected.
- **Impacted Teeth:** Clear indication of impacted anatomical structures near tooth #47 (upper right third molar) and tooth #17 (lower left third molar).
- **Calculus:** Suspicious for heavy calculus deposition on tooth #22 (upper right lateral incisor) and tooth #11 (lower right central incisor).

No restorations, crowns, root canal treatments, or implants were identified within the field of view.

- Impacted anatomical structures near tooth #47 and #17 warrant evaluation for potential third molar pathology or surgical intervention.
- Calculus deposition on #22 and #11 requires professional debridement and monitoring for progression.

- Reinforce oral hygiene practices, emphasizing interproximal cleaning and calculus prevention.
- Schedule periodic radiographic assessments to monitor impacted areas for changes in morphology or resorption risk.

- Recare in 6 months for clinical and radiographic re-evaluation of calculus and impacted regions.
- Referral to an oral surgeon for further assessment of impacted third molars (#47 and #17) if symptomatic or radiographically concerning.
- Prophylactic scaling recommended for #22 and #11 to address suspected calculus.
