Grounding Caption

Medical Report

Oral Panoramic X-ray Examination Report

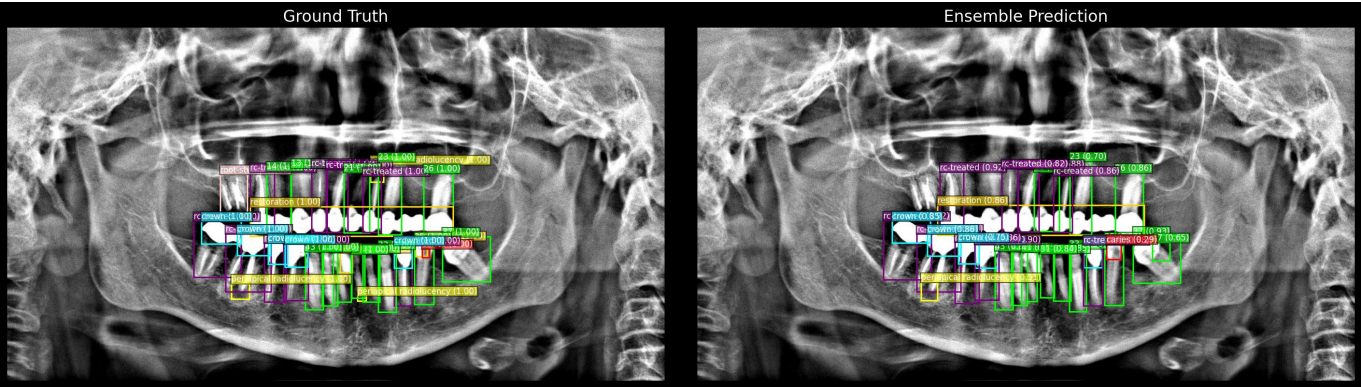
A total of 12 teeth were visualized with identifiable FDI numbering. The panoramic field demonstrates partial visibility of the dentition, with notable absence of wisdom teeth (no third molars detected). Visualized teeth include #21, #23, #26, #31, #32, #33, #35, #37, #41, #42, #43, and #47. Image quality limitations may affect detection of lower-confidence findings (e.g., #23 and #47, with scores of 0.7 and 0.65, respectively).

1. **Suspicious for periapical radiolucency** near **#43**, consistent with potential apical pathology.
2. **Suspicious for caries** near **#35**, requiring further evaluation for confirmation.

1. **#21**: Evidence of root canal treatment (multiple segments), associated restoration, and crown.
 2. **#33**: Root canal-treated tooth with no visible restoration.
 3. **#35**: Presence of a crown adjacent to suspicious caries.
 4. **#43**: Extensive root canal treatment (multiple segments), crowns, and restorations near suspicious periapical radiolucency.
-

1. **High suspicion for periapical radiolucency near #43** (likely apical periodontitis) despite prior root canal treatment.
2. **Potential caries on #35** adjacent to existing crown; concerns for secondary caries or marginal breakdown.
3. **No wisdom teeth detected**, consistent with agenesis or complete absence.

1. Reinforce oral hygiene education, emphasizing interproximal cleaning around #43 and #35.
2. Monitor areas of concern (e.g., suspicious caries near #35) with serial imaging and clinical correlation.
3. Consider dietary counseling to reduce cariogenic risk.

1. **Urgent referral to endodontist** for evaluation of #43 to confirm apical pathology and assess need for retreatment or apicoectomy.
 2. **Referral to general dentist** for reassessment of #35's crown integrity and caries management.
 3. **6-month recall** for imaging follow-up to monitor suspicious regions.
 4. Schedule **periodic panoramic imaging** to track changes in apical status and overall restorative outcomes.
-
