### Grounding Caption

# Medical Report

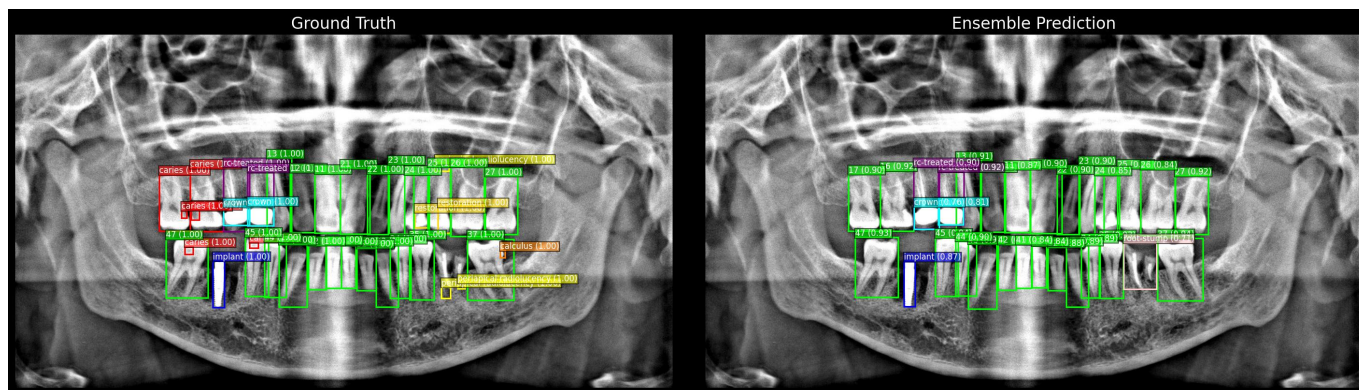
This localization caption provides multi-dimensional spatial analysis of anatomical structures and pathological findings for this panoramic dental X-ray image, including:

A total of 24 teeth are visualized within the panoramic field. No wisdom teeth (third molars) are present bilaterally. The dentition demonstrates standard anatomical positioning with no evidence of gross displacement.

A suspicious area consistent with a root stump is noted near tooth #35. The lesion appears as a radiopaque structure adjacent to the apical region, suggesting a retained fragment or incomplete resorption. Further diagnostic evaluation is indicated to confirm the nature of this finding.

- Root canal-treated (rc-treated) status is confirmed for teeth #13 and #16.
  - A crown restoration is present on tooth #13.
  - A crown restoration is also documented on tooth #16.
  - A dental implant is identified near tooth #47, positioned within the edentulous space.
-

- **Suspicious root stump near #35:** Requires clinical correlation and possible 3D imaging (e.g., CBCT) to assess for residual root fragments or pathologic changes.
- **Implant site near #47:** Monitor for peri-implant radiolucency or signs of inflammation during routine recall.

- Reinforce oral hygiene protocols for the posterior mandibular region to mitigate caries risk.
- Schedule periodic radiographic evaluation of the #35 area for progression monitoring.

- **Referral to endodontics/periodontics:** For definitive diagnosis and management of the #35 lesion.
- **6-month recall:** To assess stability of the #47 implant and overall restorative health.
- **Annual panoramic imaging:** To track long-term outcomes of the #35 area and implant integration.
