# Medical Report

## Oral Panoramic Radiographic Examination Report

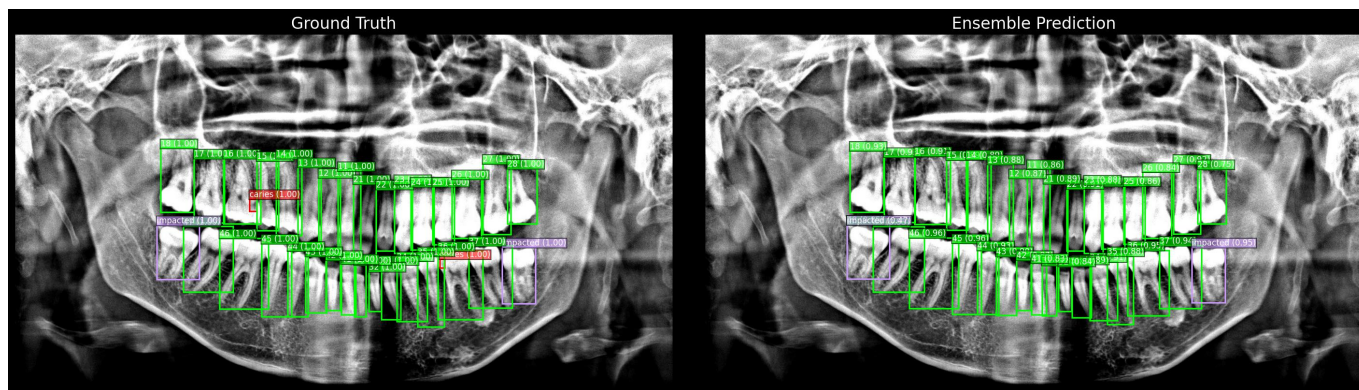
A total of 31 teeth are visualized, with all primary dentition structures accounted for except for a missing upper left third molar (#28). Wisdom teeth analysis reveals:

- **Tooth #18 (lower left third molar):** Fully erupted, non-impacted.
- **Tooth #48 (lower right third molar):** Impacted (horizontal orientation).
- **Tooth #28 (upper right third molar):** Fully erupted, non-impacted.

Dentition demonstrates no significant attrition or malalignment.

- **Tooth #48:** Suspicious for impacted wisdom tooth (low confidence).
- **Near tooth #37:** Clear indication of impacted structures, likely a horizontally positioned radiopaque mass compressing the distal aspect of #37.

No evidence of caries, periapical radiolucency, or osseous pathology.

No prior restorative treatments (fillings, crowns, root canal therapy) or implants observed.

- Impacted lower right third molar (#48):** Requires evaluation for surgical extraction due to high risk of pericoronitis and caries.
- Impacted structures near #37:** Suspected horizontal impaction adjacent to lower right second molar, necessitating 3D imaging (CBCT) for precise localization.

- Reinforce interdental cleaning techniques to minimize biofilm accumulation around impacted #48.
- Monitor for early signs of infection (e.g., swelling, pain) in the #37 region.

- **Referral to oral surgeon:** For surgical planning and extraction of #48.
  - **CBCT imaging:** To assess anatomical relationship of impacted structures near #37.
  - **6-month recall:** For clinical and radiographic monitoring of unresolved areas.
-
