Grounding Caption

Medical Report

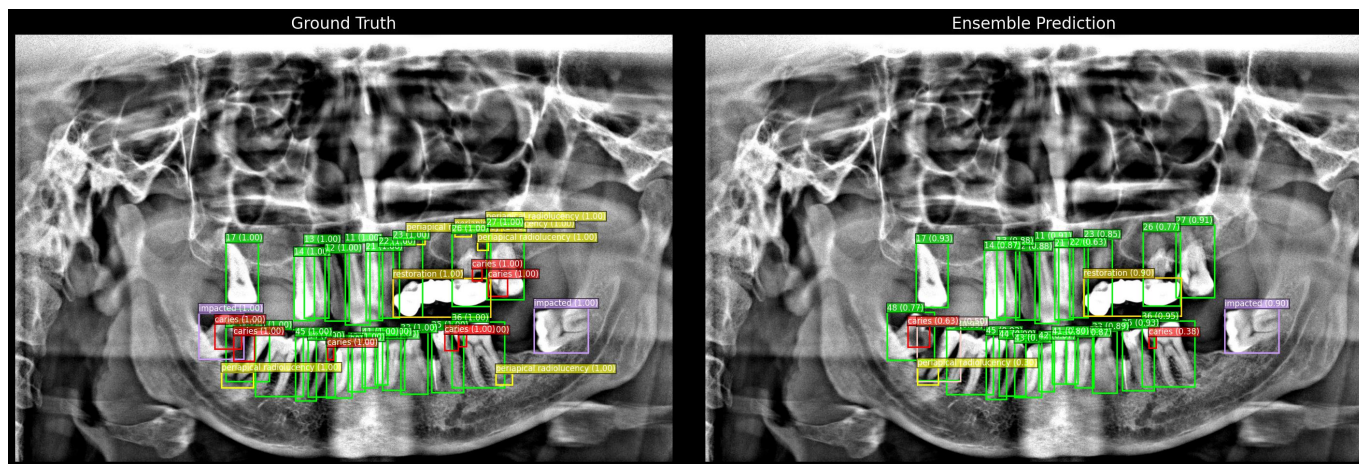
A total of 23 teeth are visualized within the panoramic field. The maxillary and mandibular dentition demonstrate adequate alignment and spatial distribution. Wisdom teeth are partially represented: #48 (mandibular right third molar) is fully erupted and unimpacted, while no definitive visualization of other third molars is noted.

- #47 (mandibular left first molar): Suspicious for residual root structure with incomplete resorption.
- Near tooth #36 (maxillary right first molar): Indicates impacted tooth formation in the posterior region.
- Near tooth #48 (mandibular right third molar): Suggests early carious lesion on the mesial surface.
- Near tooth #36 (maxillary right first molar): Areas of concern for non-cavitated carious lesion on the distal surface.
- Near tooth #47 (mandibular left first molar): Periapical radiolucency is observed, suggesting possible apical pathology.

- Near tooth #23 (maxillary right central incisor): Presence of a well-maintained restoration with no evidence of recurrent caries.
-

- **Impacted tooth formation near #36:** Requires evaluation for surgical removal planning.
- **Caries near #48 and #36:** Immediate preventive or restorative intervention recommended.
- **Periapical radiolucency near #47:** Further diagnostic imaging (e.g., CBCT) and endodontic consultation advised.
- **Residual root structure on #47:** Surgical extraction consideration to mitigate infection risk.

- Reinforce biofilm control protocols, particularly around #48 and #36, to arrest cariogenic activity.
- Implement dietary counseling to reduce fermentable carbohydrate exposure.
- Monitor periapical health of #47 at 3-month intervals.

- Schedule a 3-month recall for re-evaluation of carious lesions and impacted tooth status.
- Refer to an oral surgeon for removal of impacted tissue near #36 and extraction of residual root on #47.
- Endodontic consultation for #47 to confirm periapical pathology etiology.
- Routine check of restoration on #23 during the next 6-month maintenance visit.
