Grounding Caption

Medical Report

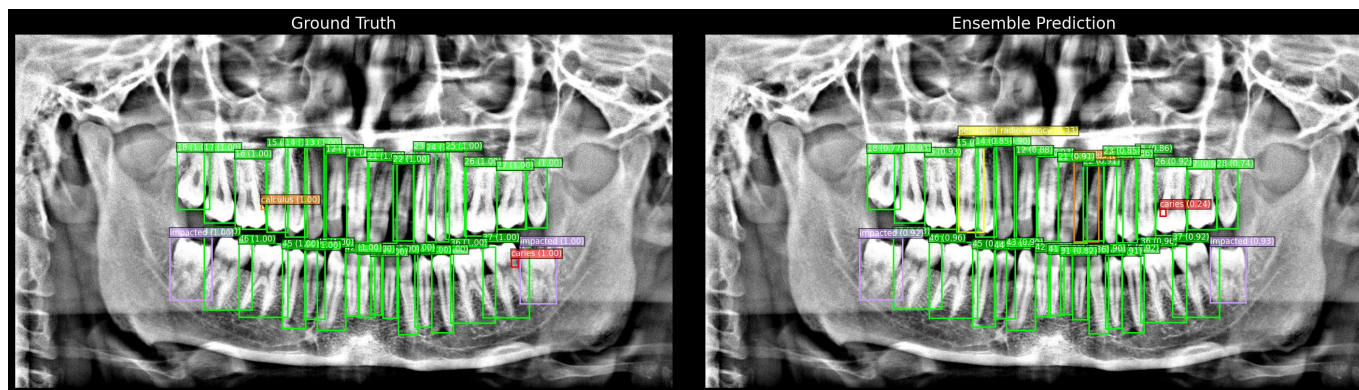
Teeth visibility with center points (total: 30):

Dental Pathological Findings (total: 5):

```
[
{'box_2d': [669, 265, 736, 521], 'tooth_id': '15', 'label': 'periapical radiolucency', 'score': 0.33},
{'box_2d': [975, 329, 1041, 546], 'tooth_id': '22', 'label': 'calculus', 'score': 0.43},
{'box_2d': [1336, 558, 1430, 707], 'tooth_id': 'unknown', 'label': 'impacted', 'score': 0.93, 'near_tooth': '37'},
{'box_2d': [407, 536, 521, 700], 'tooth_id': 'unknown', 'label': 'impacted', 'score': 0.92, 'near_tooth': '47'},
{'box_2d': [1203, 459, 1218, 479], 'tooth_id': 'unknown', 'label': 'caries', 'score': 0.24, 'near_tooth': '26'}
]
```

A total of 30 teeth are visualized within the panoramic field. Wisdom teeth (#18 and #28) are present and not impacted. All remaining teeth demonstrate normal alignment and radiographic density, with no evidence of gross caries or fractures.

- **Tooth #15:** Suspicious for a periapical radiolucency at the apical region, suggesting potential apical pathology.
- **Tooth #22:** Suggests localized calculus deposits along the cervical margin, likely contributing to gingival inflammation.
- **Near tooth #37:** Clear indication of an impacted tooth structure lateral to the visible crown.
- **Near tooth #47:** Clear indication of an impacted tooth structure lateral to the visible crown.
- **Near tooth #26:** Suspicious for an early carious lesion at the interproximal surface, requiring further evaluation for confirmation.

- Presence of impacted tooth fragments near #37 and #47, requiring surgical assessment for potential removal.
- Suspected periapical radiolucency at #15, warranting endodontic evaluation to rule out apical periodontitis.
- Suspicious interproximal caries near #26, necessitating intraoral imaging (e.g., bitewing radiograph) for definitive diagnosis.

- Reinforce plaque control and calculus removal through scaling and polishing, particularly around #22.
- Emphasize flossing and interdental cleaning to mitigate caries risk near #26.
- Monitor impacted areas near #37/#47 for signs of resorption or infection.

- Schedule a 3-month recall for clinical and radiographic reassessment of #15 and #26.
- Referral to an oral surgeon for evaluation of impacted fragments near #37 and #47.
- Consider additional imaging (e.g., cone-beam CT) for precise localization of impacted structures.
