Grounding Caption

Medical Report

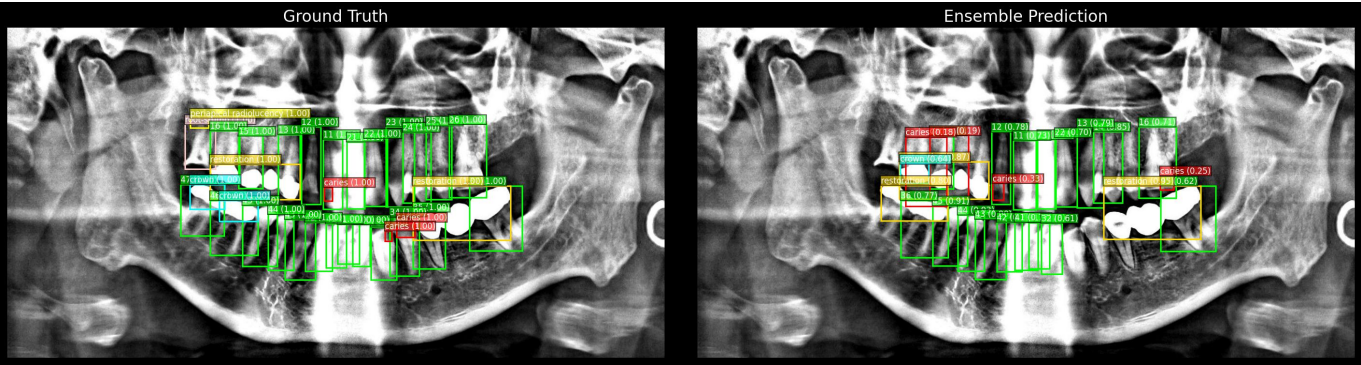
A total of 17 teeth are visualized within the panoramic field. No wisdom teeth (third molars) are present bilaterally. The dental arches exhibit partial edentulism, with missing teeth identified as #47, #46, #36, and #41–#45 (left posterior quadrant).

- **#15 (Left Mandibular First Premolar):** Suspicious for carious lesion at the mesial aspect.
- **Near #12 (Right Maxillary Lateral Incisor):** Areas of concern noted for potential caries in the interproximal region.
- **Near #16 (Right Maxillary Second Molar):** Areas of concern for caries near the distal surface.
- **Near #15 (Left Mandibular First Premolar):** Additional suspicious radiolucent area consistent with early carious involvement.

- **#47 (Right Mandibular Second Molar):** Presence of a restoration (filling) with intact margins.
 - **Near #15 (Left Mandibular First Premolar):** Two distinct restorations documented, one overlapping with the suspicious carious lesion.
 - **Near #36 (Left Maxillary First Molar):** Restoration noted in the mesial aspect.
 - **Near #15 (Left Mandibular First Premolar):** Crown-like radiopaque structure observed, likely a prior crown or onlay.
-

- Deep suspicious caries on #15 (left mandibular first premolar) and associated restorative challenges.
- Potential interproximal caries near #12 (right maxillary lateral incisor) and #16 (right maxillary second molar).

- Reinforce oral hygiene practices, emphasizing interproximal cleaning (e.g., flossing, interdental brushes) to prevent progression of lesions near #12 and #16.
- Monitor existing restorations on #47 and near #15 for secondary caries or marginal breakdown.

- **6-month recall** for digital radiographic reassessment, particularly for #15, #12, and #16.
- **Referral to restorative dentistry** for evaluation of #15 to determine if endodontic intervention or crown replacement is required due to caries proximity to the restoration/crown.
- Consider **bitewing radiographs** for confirmation of interproximal caries in #12 and #16.
