Grounding Caption

Medical Report

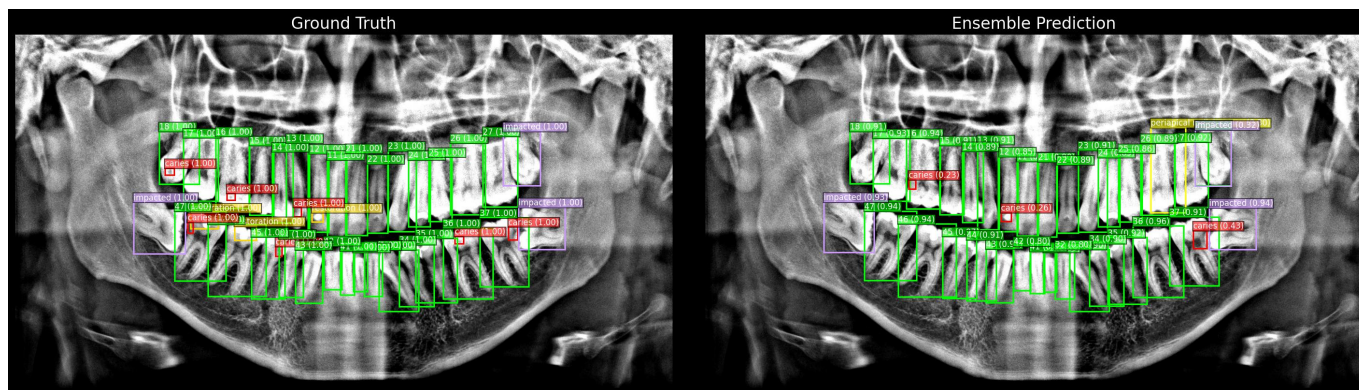
This localization caption provides multi-dimensional spatial analysis of anatomical structures and pathological findings for this panoramic dental X-ray image, including:

A total of 30 teeth are visualized within the panoramic field. The maxillary right and left wisdom teeth (#18 and #38) are not depicted. The mandibular right wisdom tooth (#28) is impacted, while the mandibular left wisdom tooth (#18) is fully erupted.

- #26 demonstrates a suspicious radiolucency at the apical region, suggesting possible periapical pathology.
- #28 is impacted in the mandible with horizontal orientation, confirmed by bony obstruction.
- A sign of impacted tooth is noted near #37, consistent with a developing molar in the maxilla.
- A sign of impacted tooth is observed near #47, indicating a partially erupted maxillary molar.
- Suspected carious lesion is identified near #37, requiring further evaluation.
- Areas of concern for early caries are observed near #12 and #16, with minimal radiolucency.

No prior restorations, crowns, root canal treatments, or implants are detected.

1. Impacted mandibular right wisdom tooth (#28) with bony impaction, necessitating surgical evaluation.
2. Periapical radiolucency at #26 (suspicious for apical periodontitis), requiring endodontic assessment.
3. Impacted developmental tooth near #37 and #47, monitored for space maintenance and eruption potential.
4. Suspected early caries near #37, #12, and #16, prioritized for preventive intervention.

- Reinforce biofilm control and plaque management near regions of suspected caries (#37, #12, #16).
- Monitor impacted molar (#28) for signs of pericoronitis or cystic development.

- 6-month recall for radiographic monitoring of impacted #28 and carious lesions.
- Referral to endodontist for definitive diagnosis and treatment planning of #26.
- Surgical consultation for impacted #28 to evaluate extraction feasibility.
- Adjunctive caries detection (e.g., laser fluorescence) recommended for high-risk areas (#37, #12, #16).
