Grounding Caption

Medical Report

Oral Panoramic Radiographic Examination Report

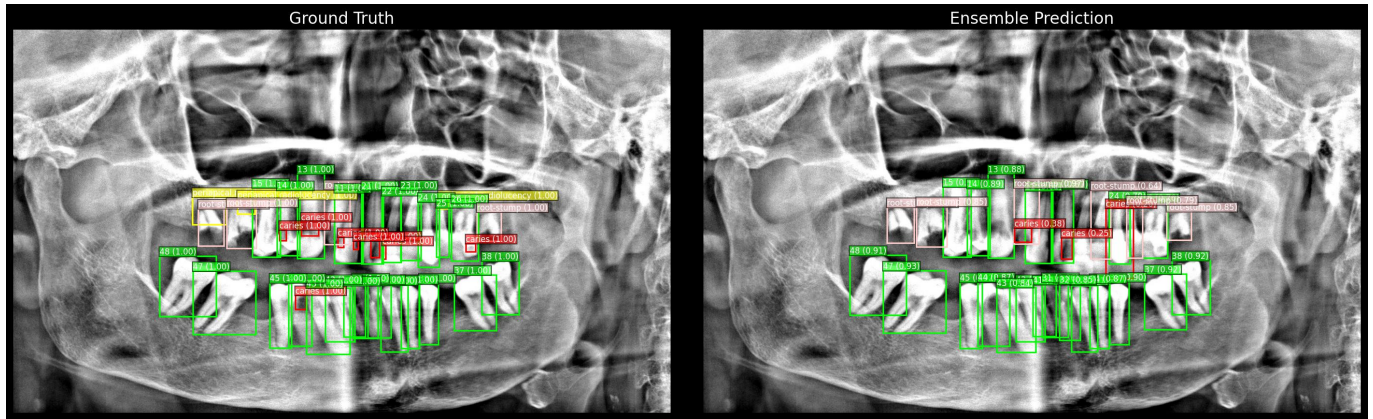
A total of 21 teeth are visualized within the field of view. Wisdom teeth (FDI #48 and #38) are present and non-impacted. No evidence of supernumerary or missing teeth is noted.

- **#24 (upper left first molar):** Suspicious for caries in the mesial surface (low confidence due to overlapping anatomical structures).
- **Near #11 (upper left lateral incisor):** A suspicious radiolucency consistent with residual root stump (score < 0.80).
- **Near #15 (upper left first molar):** Two distinct root stumps identified (one with 0.88 confidence, one with 0.85 confidence).
- **Near #26 (upper right second molar):** A root stump is observed (0.85 confidence).
- **Near #24 (upper left first molar):** Additional root stumps and suspicious caries detected (0.79 and 0.64 confidence, respectively).
- **Near #21 (upper right lateral incisor):** A suspicious radiolucency consistent with early caries (0.25 confidence).

1. **Deep caries suspicious on #24 (upper left first molar).**
2. **Multiple residual root stumps near #15, #24, and #26, indicating prior extractions.**
3. **Early caries suspicious on #21 (upper right lateral incisor) requiring close monitoring.**

- Reinforce oral hygiene protocols, emphasizing interproximal cleaning for caries-prone areas.
- Monitor residual root stumps for signs of infection or resorption.
- Advise patient to maintain fluoride exposure and regular dental hygiene visits.

- **3-month recall** for reassessment of suspicious caries on #24 and #21.
 - **6-month recall** to evaluate stability of residual root stumps and confirm absence of periapical pathology.
 - Referral to endodontic specialist if caries progress or root stumps demonstrate resorptive changes.
-
