Medical Report

Oral Panoramic Radiographic Examination Report

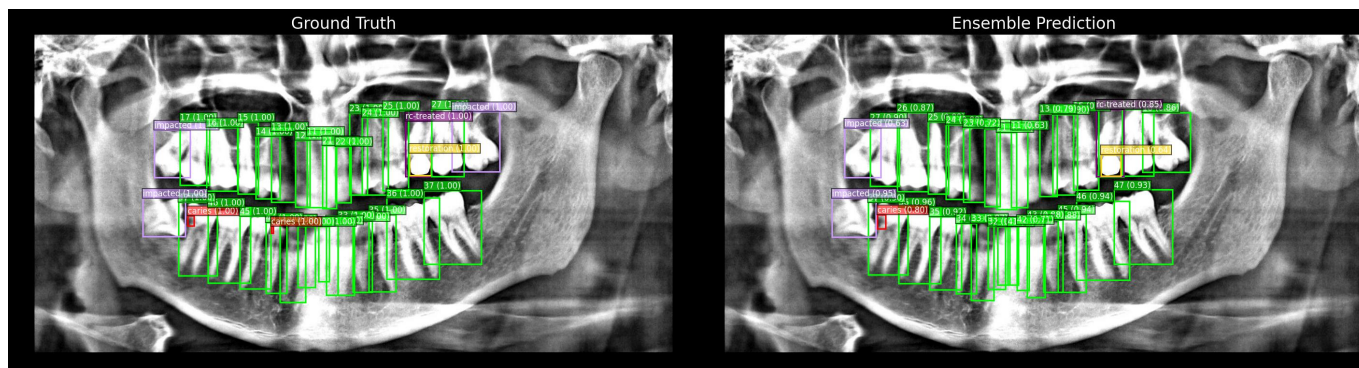
A total of 28 teeth are visualized within the imaging field. The right lower third molar (#18) is fully erupted and unimpacted. No other wisdom teeth are identified in the dataset.

- **Tooth #37:** A distinct radiopaque area is observed near the distal root, indicating an impacted structure.
- **Near tooth #37:** Evidence of a carious lesion is noted within the interproximal region.
- **Near tooth #27:** A suspicious radiopaque density is identified, raising concern for an impacted structure.

- **Tooth #16:** Presence of a root canal-treated tooth with a radiopaque filling material.
 - **Near tooth #16:** A restoration is present in the mesial region, consistent with prior restorative intervention.
-

1. **Impacted structure near #37** requiring clinical evaluation for potential surgical intervention.
2. **Significant caries near #37** necessitating prompt restorative treatment.
3. **Suspicious radiopacity near #27** for follow-up imaging or surgical exploration.
4. **Root canal-treated #16** should be assessed for stability and restoration integrity.

- Reinforce oral hygiene protocols, particularly around #37 and #27, to prevent secondary caries.
- Apply fluoride treatments to caries-prone areas.
- Monitor for signs of infection or mobility in the impacted regions.

- Schedule a **6-month recall** for radiographic reassessment of #37 and #27.
 - Refer to an **oral surgeon** for definitive management of impacted structures.
 - Consult an **endodontist** for evaluation of the root canal-treated #16 and adjacent restoration.
-
