Grounding Caption

Medical Report

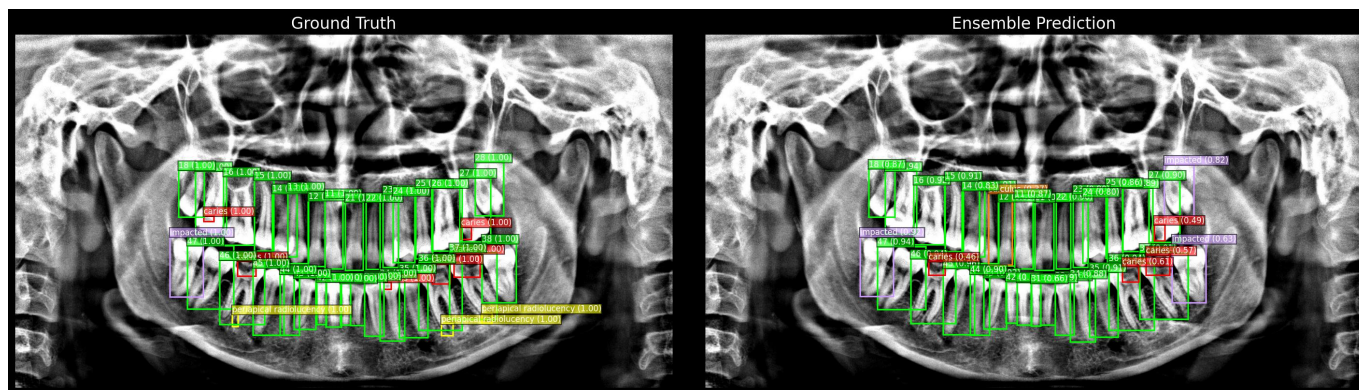
A total of 29 teeth are visualized in the panoramic image. Wisdom teeth status: #18 is present and not impacted. No evidence of other wisdom teeth in the field of view.

- Suspicious for calculus on #12.
- Impacted tooth noted near #47.
- Impacted tooth suspected near #27.
- Suspicious for impacted tooth near #37.
- Suspicious for caries near #36.
- Suspicious for caries near #37.
- Suspicious for caries near #27.
- Suspicious for caries near #46.

No prior restorative treatments, root canal therapy, crowns, or implants identified in the field of view.

1. Impacted tooth near #47 requires evaluation for potential surgical removal.
2. Suspicious calculus on #12 warrants periodontal assessment.
3. Areas of suspected caries near #36, #37, and #27 necessitate confirmation via supplemental imaging or clinical correlation.

- Reinforce oral hygiene protocols to mitigate calculus accumulation.
- Monitor impacted regions near #27 and #37 for signs of infection or resorption.

- 6-month recall for reassessment of calculus and impacted teeth.
- Referral to a periodontist for calculus management on #12.
- Referral to an endodontist for evaluation of carious lesions near #36 and #37.
- Consider panoramic review in 3 months to monitor suspicious caries near #27 and #46.
