Grounding Caption

This localization caption provides multi-dimensional spatial analysis of anatomical structures and pathological findings for this panoramic dental X-ray image, including:

Medical Report

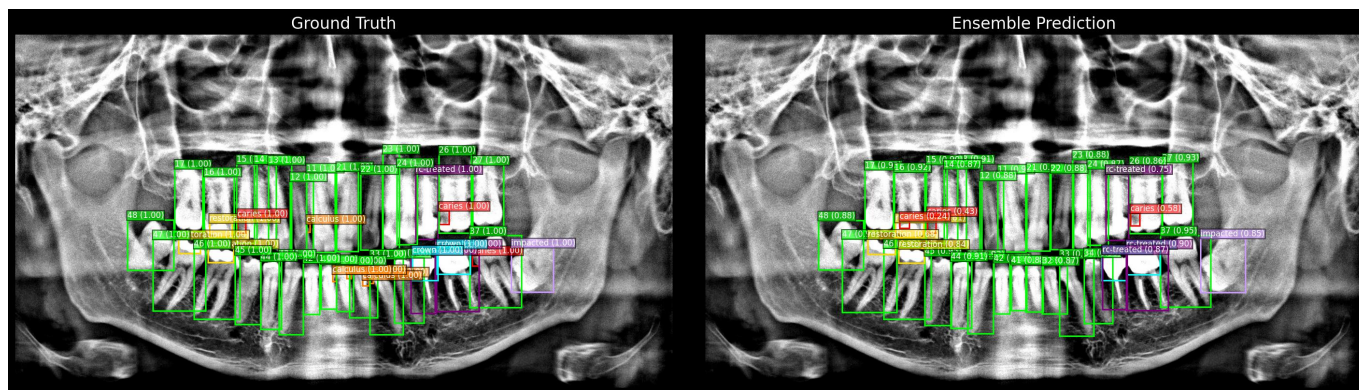
A total of 27 teeth are visualized, with the exception of #25, which is partially visualized (confidential score: 0.6, suggesting incomplete visualization). Wisdom teeth status: #48 is present and non-impacted; no evidence of impaction is noted for visualized wisdom teeth.

- Sign of impacted tooth near #37 (FDI #37).
- Suspicious for caries near #25 (FDI #25).
- Areas of concern noted for caries near #15 (FDI #15) and #16 (FDI #16).

- Rc-treated tooth noted for #25 (FDI #25).
- Presence of a crown on #37 (FDI #37) and #34 (FDI #34).
- Rc-treated teeth documented near #37 and #34.
- Restorations identified near #46 (FDI #46), #16, and #47.

- Impacted tooth near #37 requires clinical evaluation to determine treatment urgency.
- Suspected caries near #15, #16, and #25 necessitate diagnostic confirmation (e.g., intraoral imaging) and intervention.
- Monitor rc-treated #25 for secondary caries or structural compromise.

- Reinforce oral hygiene protocols to mitigate caries progression in #15, #16, and #25.
- Schedule regular prophylaxis to address potential areas of calculus buildup.

- Refer to oral surgery for impacted tooth near #37; reassess in 6–8 weeks post-referral.
- Schedule 6-month recall for monitoring caries in #15, #16, and #25.
- Coordinate with endodontist for definitive evaluation of #25 if symptoms emerge.
