Grounding Caption

This localization caption provides multi-dimensional spatial analysis of anatomical structures and pathological findings for this panoramic dental X-ray image, including:

Medical Report

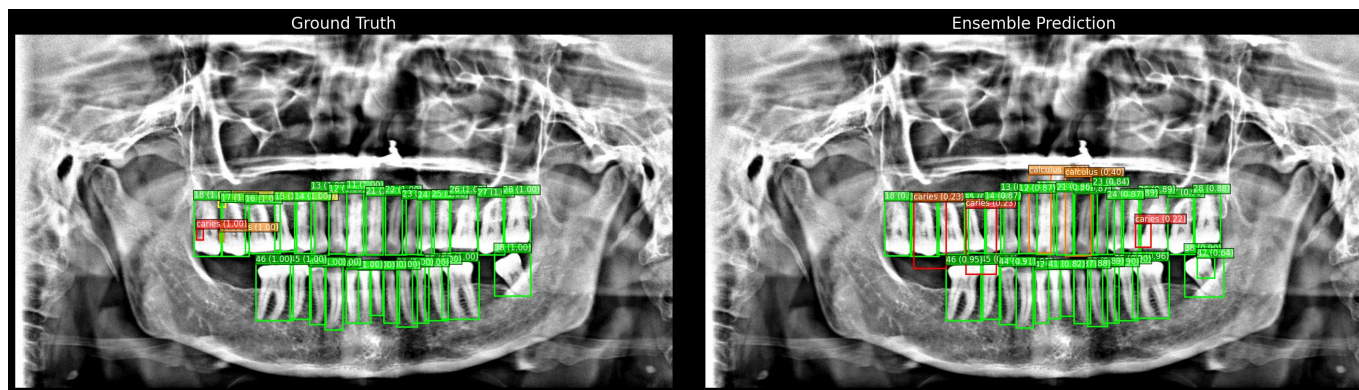
A total of 30 teeth are visualized on the panoramic image. Wisdom teeth (#18, #28, #38) are present and not impacted.

- #17 (upper left first molar): Suspicious for caries.
- #15 (upper left second premolar): Suspicious for caries.
- #11 (upper left central incisor): Suspicious for calculus.
- #22 (lower left lateral incisor): Suspicious for calculus.
- Area near #26 (lower right first molar): Suspicious for caries.

No restorations, crowns, root canal treatments, or implants identified.

- Areas of concern for caries on #17, #15, and near #26.
- Possible calculus accumulation on #11 and #22.

- Reinforce oral hygiene practices, including interdental brushing and flossing, to address calculus suspicion.
- Monitor carious lesions for progression and consider dietary counseling to reduce caries risk.

- Schedule a 6-month recall for clinical evaluation of suspicious caries and calculus.
- If caries near #26 confirm on clinical examination, refer for targeted intervention.
- Consider radiographic follow-up for #17 and #15 to clarify caries extent.
