Grounding Caption

This localization caption provides multi-dimensional spatial analysis of anatomical structures and pathological findings for this panoramic dental X-ray image, including:

Medical Report

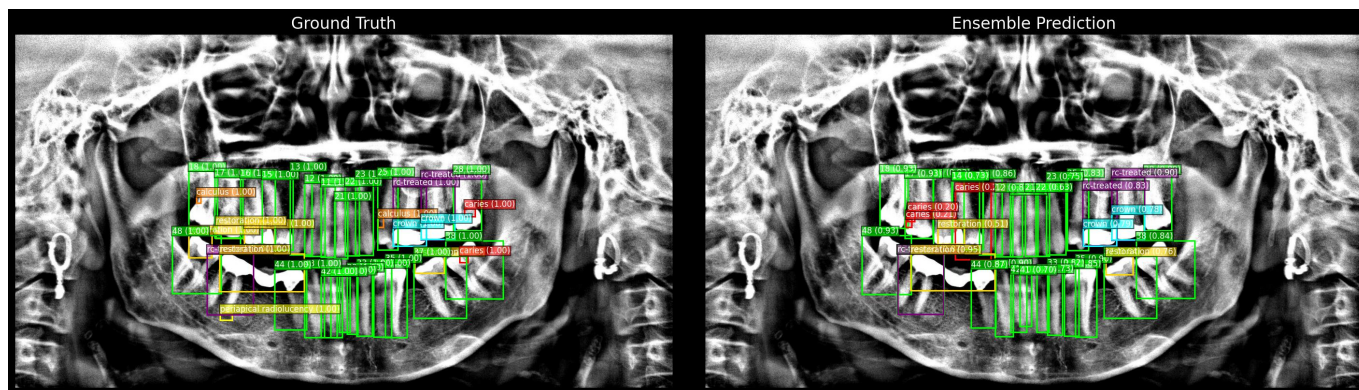
Teeth visibility with center points (total: 25):

Wisdom teeth detection (total: 4):

Dental Pathological Findings (total: 3):

```
[
{'box_2d': [660, 414, 756, 594], 'tooth_id': '15', 'label': 'caries', 'score': 0.22},
{'box_2d': [531, 486, 545, 507], 'tooth_id': 'unknown', 'label': 'caries', 'score': 0.21, 'near_tooth': '17'},
{'box_2d': [535, 466, 553, 492], 'tooth_id': 'unknown', 'label': 'caries', 'score': 0.2, 'near_tooth': '17'}
]
```

Historical Treatments (total: 8):

```
[
{'box_2d': [508, 578, 630, 738], 'tooth_id': '47', 'label': 'rc-treated', 'score': 0.87},
{'box_2d': [543, 579, 675, 675], 'tooth_id': 'unknown', 'label': 'restoration', 'score': 0.95, 'near_tooth': '47'},
{'box_2d': [1074, 376, 1162, 543], 'tooth_id': 'unknown', 'label': 'rc-treated', 'score': 0.9, 'near_tooth': '28'},
{'box_2d': [998, 410, 1088, 557], 'tooth_id': 'unknown', 'label': 'rc-treated', 'score': 0.83, 'near_tooth': '25'},
{'box_2d': [999, 511, 1088, 557], 'tooth_id': 'unknown', 'label': 'crown', 'score': 0.79, 'near_tooth': '25'},
{'box_2d': [1074, 473, 1161, 541], 'tooth_id': 'unknown', 'label': 'crown', 'score': 0.78, 'near_tooth': '28'},

1. General Condition

A total of 25 teeth are visualized, including four unimpacted wisdom teeth: #18, #48, #28, and #38. No significant anatomical abnormalities or missing teeth are noted.

2. Pathological Findings

- **Tooth #15:** Suspicious for caries at the mesial surface.
- **Near tooth #17:** Two areas of concern for caries at adjacent interproximal regions.

3. Historical Interventions

- **Tooth #47:** Presence of a root canal-treated (rc-treated) tooth with an adjacent restoration.
 - **Near teeth #25 and #28:** Root canal-treated teeth with corresponding crowns.
 - **Near tooth #37:** Restoration present.
 - **Near tooth #16:** A questionable restoration is observed; further clinical evaluation is recommended.
-

Priority Concerns

- Suspicious caries on tooth #15 and near tooth #17 require immediate clinical correlation and possible restorative intervention.

Preventive Measures

- Reinforce interproximal oral hygiene practices, particularly around the #17 region.
- Monitor for progression of questionable caries on #15.

Follow-up Protocol

- Schedule a 3-month recall for reassessment of suspicious caries.
- Refer to a dentist for definitive diagnosis and treatment planning for #15 and #17.
- Continue 6-month recall for monitoring of historical restorations and root canal-treated teeth.
