Medical Report

Oral Panoramic Radiographic Examination Report

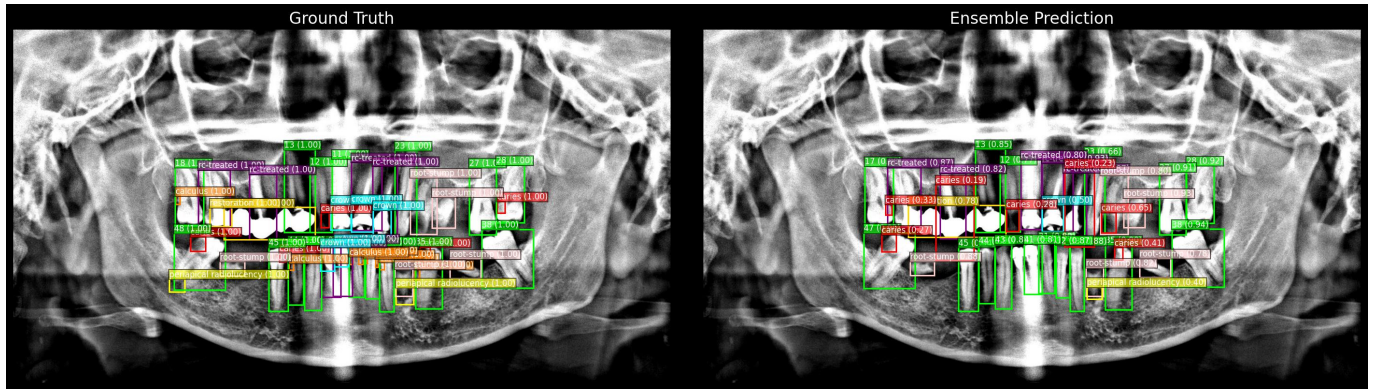
A total of 16 teeth are visualized within the panoramic field. Wisdom teeth #38 (right maxillary) and #28 (left mandibular) are present and unimpacted.

- Clear indication of root stumps near teeth #27 (score 0.93), #47 (0.88), and #33 (0.82).
- Suspicious for root stumps near teeth #23 (0.80), #35 (0.78), and #35 (0.78).

- Evidence of caries near teeth #23 (0.65) and #12 (0.28).
- Areas of concern noted for suspected caries near teeth #35 (0.41), #17 (0.33), #47 (0.27), and #13 (0.19).

- Suspicious for periapical radiolucency near tooth #33 (0.40).

- Areas of carious involvement observed near tooth #23 (0.23) and #13 (0.19) require further clinical correlation.

- Presence of a crown near tooth #12.
- Evidence of restorations near teeth #13 and #23.

- Root canal-treated teeth identified near #12, #13, #17, and #23.

- Root stumps near teeth #27, #47, and #33 indicate prior extractions requiring documentation.
- Root canal-treated teeth at #12, #13, #17, and #23 necessitate evaluation for long-term prognosis.
- Suspicious carious lesions near teeth #23, #12, and #35 warrant clinical correlation to rule out active decay.

- Reinforce oral hygiene protocols to mitigate caries progression in high-risk areas (#23, #12).
- Monitor suspected root stumps near teeth #23 and #35 for potential bony irregularities.

- Schedule 3-month recall for reassessment of carious lesions near #23 and #35.
- Refer to endodontist for evaluation of periapical radiolucency near #33.
- Consider radiographic correlation for low-confidence caries near #17 and #47.
