## Grounding Caption

# Medical Report

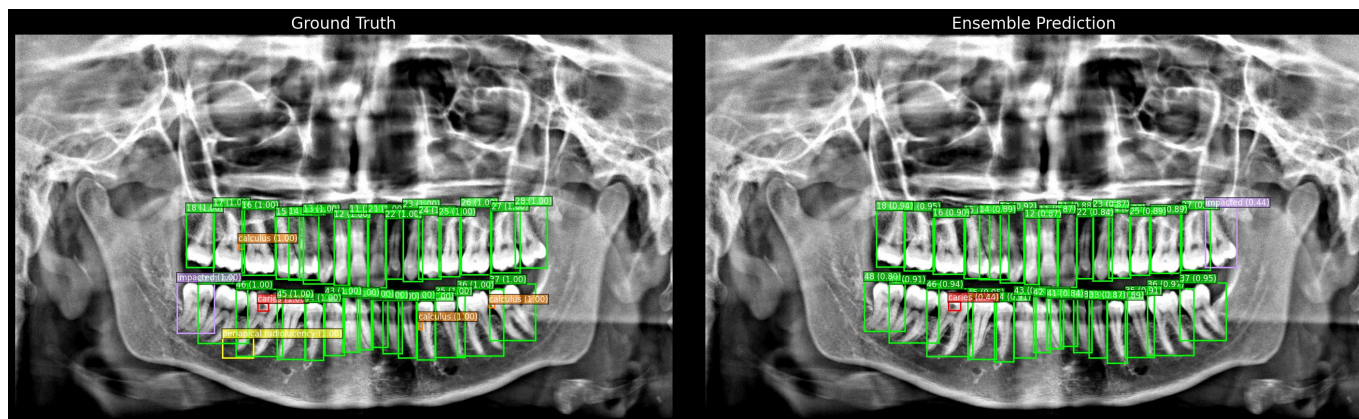
```
[
{'box_2d': [626, 688, 657, 710], 'tooth_id': 'unknown', 'label': 'caries', 'score': 0.44, 'near_tooth': '46'},
{'box_2d': [1289, 443, 1370, 600], 'tooth_id': 'unknown', 'label': 'impacted', 'score': 0.44, 'near_tooth': '27'}
]
```

A total of 30 teeth are visualized with adequate clarity. Both mandibular wisdom teeth (#38 and #48) are present and unimpacted. The overall dental arch alignment and spacing appear within normal limits.

- **#46:** Areas of concern noted for potential caries near the distal aspect of tooth #46.
- **#27:** Suspicious radiographic density adjacent to tooth #27 raises concerns for possible impacted tissue.

No restorations, crowns, root canal treatments, or implants are identified in the radiographic field.

- **Caries near #46:** Requires further clinical evaluation to confirm the presence of cariogenic activity.
- **Impacted tissue near #27:** Radiographic irregularity adjacent to tooth #27 warrants histopathological or advanced imaging assessment.

- Reinforce oral hygiene protocols, emphasizing interdental cleaning for areas near #46.
- Monitor radiographic changes in the region near #27 during follow-up visits.

- Schedule a 6-month recall for reassessment of suspicious caries near #46 and impacted tissue near #27.
- Refer to an endodontist or oral surgeon if clinical signs (e.g., pain, swelling) develop adjacent to #27 or if caries progression is confirmed.
