## Grounding Caption

# Medical Report

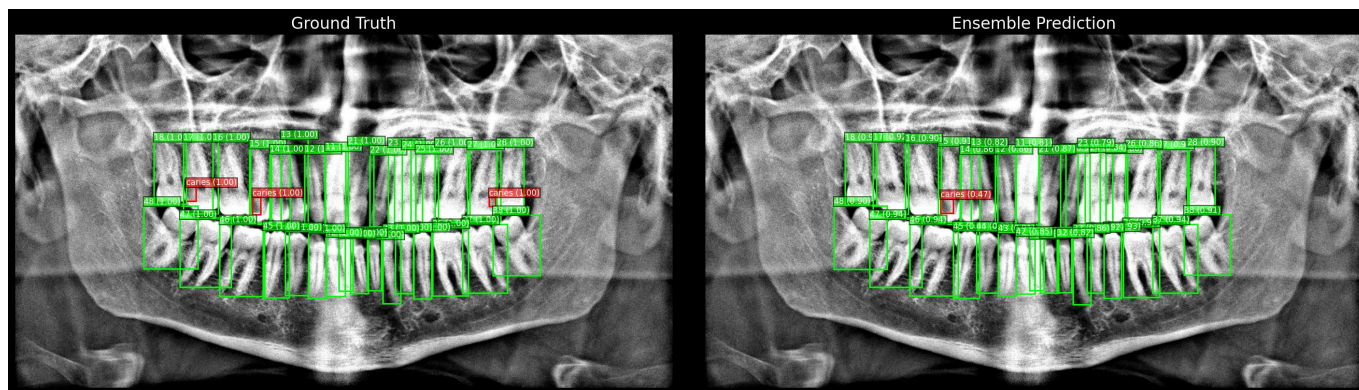
This localization caption provides multi-dimensional spatial analysis of anatomical structures and pathological findings for this panoramic dental X-ray image, including:

Teeth visibility with center points (total: 32):

Wisdom teeth detection (total: 4):

```
[
{'box_2d': [370, 282, 452, 449], 'tooth_id': '18', 'is_impacted': false, 'score': 0.93},
{'box_2d': [1266, 475, 1389, 634], 'tooth_id': '38', 'is_impacted': false, 'score': 0.91},
{'box_2d': [340, 452, 480, 620], 'tooth_id': '48', 'is_impacted': false, 'score': 0.9},
{'box_2d': [1275, 295, 1348, 469], 'tooth_id': '28', 'is_impacted': false, 'score': 0.9}
]
```

Dental Pathological Findings (total: 1):

```
[
{'box_2d': [623, 433, 655, 471], 'tooth_id': 'unknown', 'label': 'caries', 'score': 0.47, 'near_tooth': '15'}
]
```

A total of 32 teeth are visualized within the panoramic field with clear anatomical localization. All four wisdom teeth (#18, #28, #38, #48) are present and unimpacted, with normal spatial orientation.

A suspicious area suggestive of carious involvement is observed near tooth #15 (left maxillary second molar). The low confidence score ( $<0.80$ ) warrants further clinical correlation to confirm the presence of active decay.

No restorations, crowns, root canal treatments, or implants are present within the examined field.

- **Suspected carious lesion near #15:** Requires immediate clinical evaluation to determine the extent of demineralization and need for intervention.

- Reinforce oral hygiene protocols, emphasizing interproximal cleaning for the left posterior region.
- Monitor for progression of the suspicious area through follow-up imaging and clinical examination.

- **Referral to general dentist or endodontist:** For definitive diagnosis and treatment planning of the carious lesion near #15.
- **6-month recall:** For reassessment of the suspicious area and overall dental health.
- **Oral hygiene counseling:** Prioritize fluoride application and dietary modifications to mitigate caries risk.
