## Grounding Caption

# Medical Report

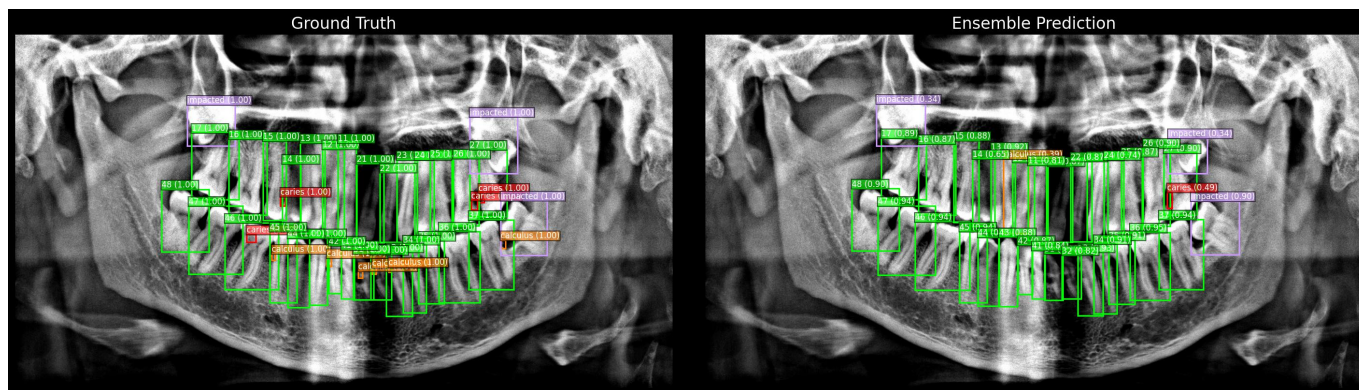
Teeth visibility with center points (total: 29):

Wisdom teeth detection (total: 1):

```
[
{'box_2d': [387, 406, 512, 571], 'tooth_id': '48', 'is_impacted': false, 'score': 0.9}
]
```

Dental Pathological Findings (total: 5):

```
[
{'box_2d': [788, 327, 855, 525], 'tooth_id': '12', 'label': 'calculus', 'score': 0.39},
{'box_2d': [1284, 439, 1412, 581], 'tooth_id': 'unknown', 'label': 'impacted', 'score': 0.9, 'near_tooth': '37'},
{'box_2d': [1221, 416, 1235, 458], 'tooth_id': 'unknown', 'label': 'caries', 'score': 0.49, 'near_tooth': '26'},
{'box_2d': [452, 182, 581, 293], 'tooth_id': 'unknown', 'label': 'impacted', 'score': 0.34, 'near_tooth': '17'},
{'box_2d': [1224, 273, 1328, 366], 'tooth_id': 'unknown', 'label': 'impacted', 'score': 0.34, 'near_tooth': '27'}
]
```

A total of 29 teeth are visualized within the panoramic field. The mandibular right quadrant (#36–#48) and maxillary left quadrant (#11–#17) demonstrate complete dentition. Wisdom teeth are partially visualized, with #48 confirmed as fully erupted and unimpacted. No radiopaque or radiolucent abnormalities are noted in the mandibular canal or maxillary sinus regions.

- **#12:** Suspicious for supragingival calculus deposition on the lingual aspect.
- **Near tooth #37:** Impacted tooth noted in the posterior mandibular region, lateral to #37, with no evidence of root resorption or cortical expansion.
- **Near tooth #26:** Area of concern for early interproximal caries on the distal aspect, potentially extending into the dentino-enamel junction.
- **Near tooth #17:** Suspicious for a horizontally impacted bony spicule in the anterior maxillary region, lateral to #17.
- **Near tooth #27:** Suspected impacted supernumerary tooth in the anterior mandibular region, lateral to #27.

No restorations, root canal-treated teeth, or implants are observed within the visualized field.

- Impacted tooth near #37 requires clinical evaluation to assess angulation and potential for eruption.
- Suspected caries near #26 warrants radiographic confirmation and preventive intervention.
- Supernumerary or impacted bony structures near #17 and #27 necessitate 3D imaging (e.g., CBCT) for definitive diagnosis.

- Reinforce oral hygiene protocols, particularly for calculus-prone areas near #12.
- Monitor suspicious carious lesion near #26 with 3-month recall for progression assessment.
- Schedule routine prophylaxis to manage calculus deposition in the mandibular anterior region.

- Referral to oral surgeon for evaluation of impacted tooth near #37.
  - Schedule 6-month follow-up with CBCT imaging for definitive diagnosis of structures near #17 and #27.
  - Initiate caries risk assessment and fluoride application for the vulnerable carious lesion near #26.
-
