Grounding Caption

This localization caption provides multi-dimensional spatial analysis of anatomical structures and pathological findings for this panoramic dental X-ray image, including:

Medical Report

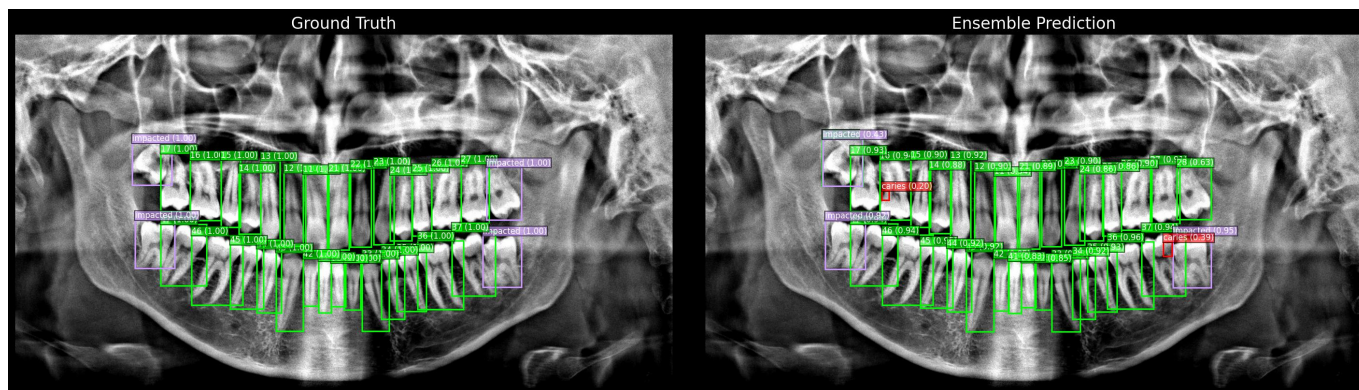
A total of 30 teeth are visualized with sufficient clarity. The maxillary and mandibular dentitions appear intact with no missing teeth noted. Wisdom teeth status: #18 (mandibular left third molar) is impacted, while #28 (mandibular right third molar) is partially erupted and non-impacted.

- **#18 (Left mandibular third molar):** Suspicious for impacted wisdom tooth with low confidence due to limited visualization.
- **Near #37 (Right maxillary first molar):** Clear indication of impacted anatomical structure adjacent to the tooth, likely a supernumerary or developmental anomaly.
- **Near #47 (Left maxillary third molar):** Sign of impacted anatomical structure adjacent to the tooth.
- **Near #37 (Right maxillary first molar):** Areas of concern noted for suspected caries in proximity, requiring further assessment.
- **Near #16 (Left mandibular first molar):** Suspicious for early carious lesion near the distal surface.

- Impacted left mandibular third molar (#18) requires evaluation for potential surgical intervention.
- Impacted anatomical structures near #37 and #47 necessitate clinical correlation to determine clinical significance.
- Suspected carious lesion near #37 and suspicious caries near #16 warrant diagnostic confirmation and treatment planning.

- Reinforce oral hygiene practices, particularly for areas near #16 and #37, to mitigate caries progression.
- Monitor for interproximal plaque accumulation in regions adjacent to impacted teeth.

- Referral to an oral surgeon for assessment and management of impacted #18.
- Schedule a 6-month recall for radiographic and clinical re-evaluation of near-#37 and #47 findings.
- Immediate diagnostic review (e.g., CBCT) for definitive caries confirmation near #16, followed by restorative intervention if indicated.
