# Medical Report

## Oral Panoramic X-ray Examination Report

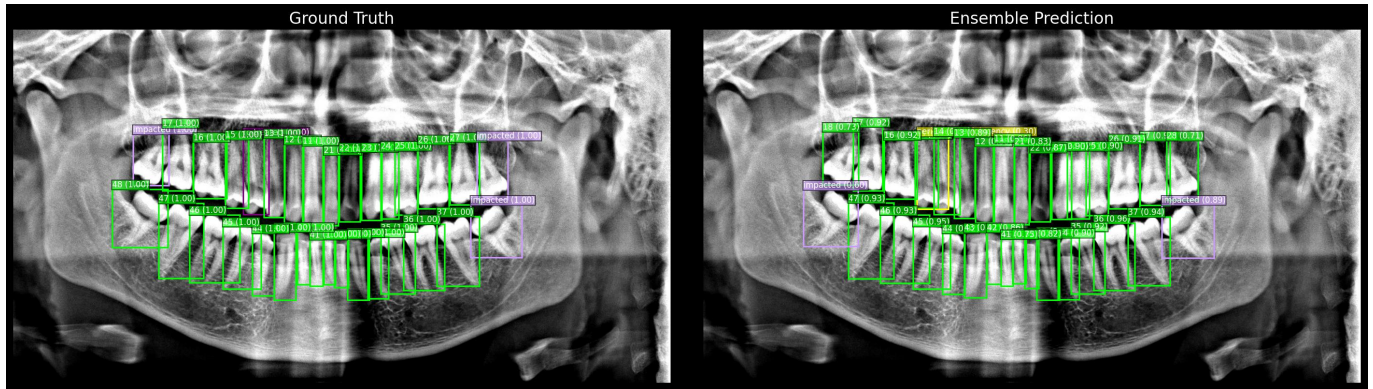
A total of 30 teeth are visualized, with full eruption of permanent dentition confirmed. Wisdom teeth (#18 and #28) are present and unimpacted. No evidence of supernumerary or missing teeth is observed.

- #15 (Left Mandibular Second Premolar):** Suspicious for periapical radiolucency at the apical region, suggesting possible apical periodontitis requiring further evaluation.
- Near #37 (Right Maxillary Second Molar):** Clear indication of impacted anatomical structure in proximity, consistent with unerupted third molar or developmental anomaly.
- Near #47 (Left Maxillary Third Molar):** Suspicious for impacted structure adjacent to the left maxillary third molar, warranting closer clinical assessment.

No prior restorative treatments (fillings, crowns, root canal therapy) or implants are detected.

- Deep suspicion of apical pathology in #15, necessitating endodontic evaluation.
- Impacted structure near #37 requires radiographic correlation and surgical planning.
- Area near #47 shows potential for impacted tooth development, requiring monitoring.

- **6-month recall** for radiographic re-evaluation of #15 and impacted regions.
  - **Referral to endodontist** for definitive diagnosis and treatment planning for #15.
  - **Referral to oral surgeon** for surgical exposure or removal of impacted structures near #37 and #47 if symptomatic.
-
