Grounding Caption

Medical Report

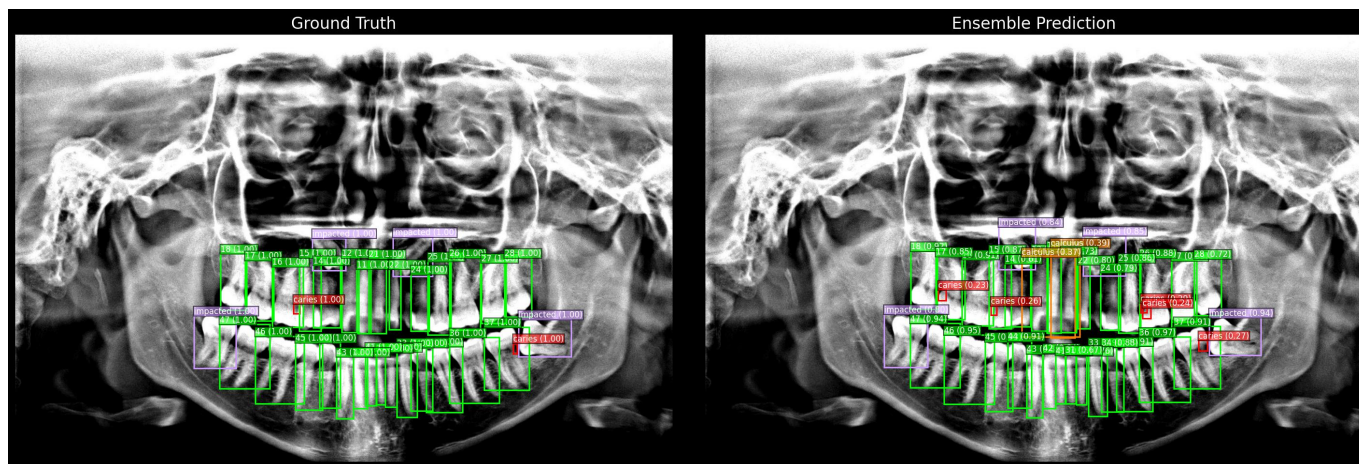
This localization caption provides multi-dimensional spatial analysis of anatomical structures and pathological findings for this panoramic dental X-ray image, including:

- A total of 28 teeth are visualized within the panoramic field.
- Wisdom teeth (#18 and #28) are present and not impacted.

- **Suspicious for calculus** on #11.
- **Impacted tooth** near #37 (clear indication of pathology).
- **Impacted tooth** near #22 (shows evidence of pathology).
- **Impacted tooth** near #15 (shows evidence of pathology).
- **Impacted tooth** near #47 (suggests possible pathology).
- **Suspicious for calculus** near #11.
- **Suspicious for caries** near #25.
- **Suspicious for caries** near #37.
- **Suspicious for caries** near #15.
- **Suspicious for caries** near #26.
- **Suspicious for caries** near #17.

- No prior restorations, root canal treatments, crowns, or implants are observed.

- Impacted teeth near #37, #22, and #15 require evaluation to rule out resorption risks or space compromise.
- Suspicious caries near #15, #17, #25, #26, and #37 necessitate clinical correlation for early intervention.
- Suspected calculus on/restoring near #11 demands professional debridement.

- Reinforce biofilm control through modified brushing and interdental cleaning near affected areas.
- Monitor impacted teeth for potential orthodontic or surgical planning.

- Schedule a 3-month recall for reassessment of caries-suspect regions.
- Refer to an oral surgeon for impacted teeth (near #37, #22, #15) if radiographic concerns persist.
- Recommend immediate recall for clinical evaluation of caries near #15, #17, #25, #26, and #37.
