Grounding Caption

ORAL PANORAMIC X-RAY EXAMINATION REPORT

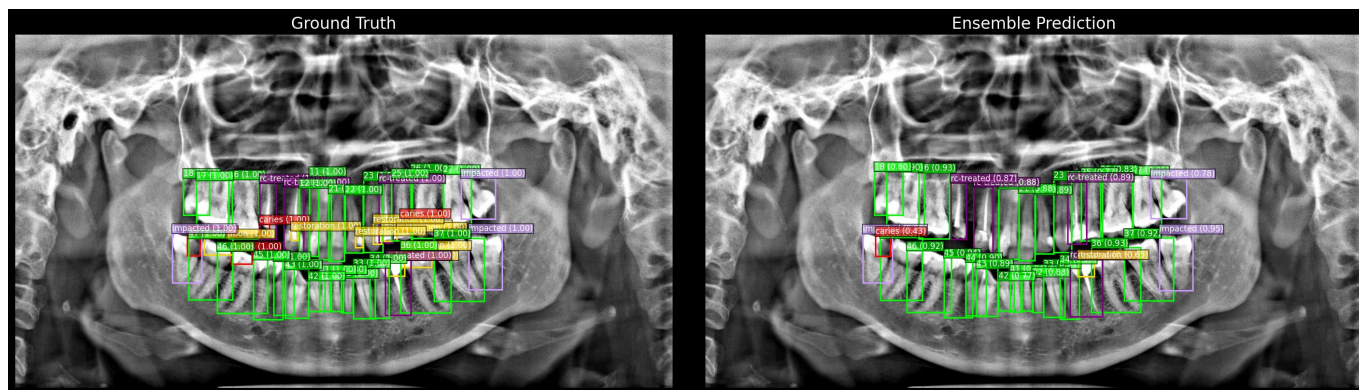
A total of **23 teeth** are visualized. Wisdom tooth #18 (left lower third molar) is fully erupted and non-impacted. Remaining wisdom teeth are not directly visualized. No signs of gross anatomical displacement or supernumerary teeth.

- Signs of impaction near tooth #37** (right upper first molar), suggesting a retained or impacted tooth in the adjacent region.
- Signs of impaction near tooth #47** (left upper first molar).
- Suspicious for impaction near tooth #27** (right lower first molar), requiring radiographic correlation.
- Suspicious for caries near tooth #47** (left upper first molar), with limited radiographic opacity.

- Root canal-treated teeth:**
 - Adjacent to tooth #34 (right lower first molar).
 - Adjacent to tooth #23 (left upper lateral incisor).
 - Adjacent to tooth #11 (right upper lateral incisor).
 - Adjacent to tooth #16 (left upper first molar).
 - Restoration adjacent to tooth #34** (right lower first molar).
-

- Impacted tooth near #37 and #47** requiring radiographic evaluation for surgical planning.
- Suspected caries near #47** necessitating clinical correlation and possible caries management.
- Suspected impaction near #27** to be assessed for orthodontic or surgical intervention.

- Reinforce oral hygiene protocols for caries-prone regions (e.g., near #47).
- Monitor for calculus accumulation in interproximal areas of multi-rooted teeth (e.g., near #34, #16).

- Schedule **3–6 month recall** for radiographic reassessment of impacted regions (#37, #47, #27).
 - Refer to **endodontist** for evaluation of root canal-treated teeth (#23, #11, #16, #34) if periapical symptoms arise.
 - Perform **high-resolution imaging** (e.g., CBCT) for detailed assessment of impacted and suspicious carious lesions.
-
