Grounding Caption

This localization caption provides multi-dimensional spatial analysis of anatomical structures and pathological findings for this panoramic dental X-ray image, including:

Medical Report

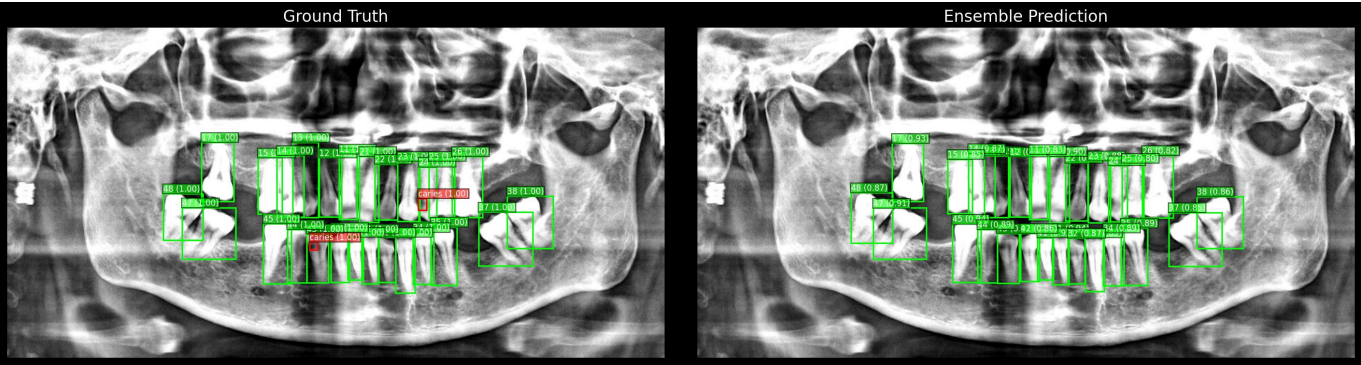
Teeth visibility with center points (total: 26):

Wisdom teeth detection (total: 2):

```
[
  {'box_2d': [331, 356, 421, 464], 'tooth_id': '48', 'is_impacted': false, 'score': 0.87},
  {'box_2d': [1078, 364, 1179, 476], 'tooth_id': '38', 'is_impacted': false, 'score': 0.86}
]
```

A total of 26 teeth are visualized within the panoramic field. The maxillary and mandibular wisdom teeth (#48 and #38, respectively) are present and fully erupted with no evidence of impaction. No significant dental abnormalities or missing teeth are observed.

No active pathologies, carious lesions, or radiolucent/radiopaque abnormalities are detected. The periodontal ligament spaces and alveolar bone appear intact.

No prior dental restorations, crowns, root canal treatments, or implants are identified.

No urgent dental issues are present.

- Reinforce routine oral hygiene practices, including interdental cleaning and fluoride use.
- Educate on dietary modifications to minimize caries risk.

- Schedule a 6-month recall for routine monitoring and panoramic re-evaluation.
- Maintain annual bitewing radiographs to screen for interproximal caries.
- Refer to an orthodontist for wisdom tooth (#38/#48) positional assessment if eruptive complications arise.
