Grounding Caption

This localization caption provides multi-dimensional spatial analysis of anatomical structures and pathological findings for this panoramic dental X-ray image, including:

Medical Report

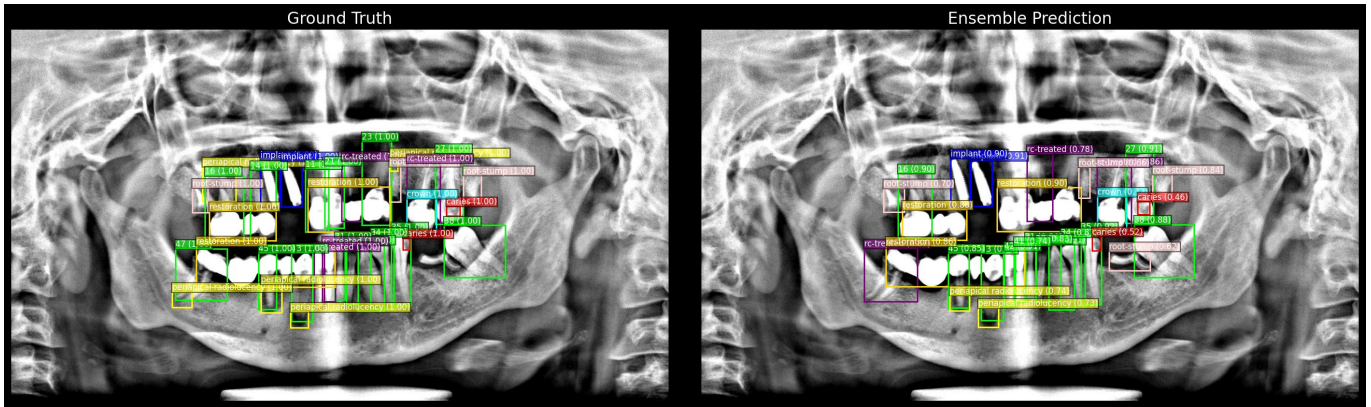
A total of 12 teeth are visualized, including the maxillary right first molar (#16), mandibular left first molar (#27), and mandibular right third molar (#38). Wisdom tooth #38 is fully erupted and not impacted. Other detected teeth include premolars and molars (FDI codes: #31, #32, #33, #34, #35, #41, #42, #43, #45).

- **Root stumps** are present near #27 (definitive) and suspicious findings near #16 and #38.
- **Periapical radiolucency** is noted near #45 (suspicious) and #43 (suspicious), suggesting possible apical pathology.
- **Caries** are suspicious near #35 and #27, requiring further clinical evaluation.

- **Restorations** are present near #16 and #31.
 - **Root canal-treated teeth** are identified near #27 and #45.
 - A **crown** is located on #27.
 - **Implants** are observed near #16, indicating prior prosthetic rehabilitation.
-

- **Root stumps near #27** require evaluation for potential endodontic or surgical intervention.
- **Periapical radiolucency near #45 and #43** suggests possible apical periodontitis; endodontic assessment is warranted.
- **Suspected caries near #35 and #27** necessitate radiographic and clinical correlation.

- Reinforce oral hygiene protocols to mitigate caries progression in #35 and #27.
- Monitor suspicious periapical radiolucencies for changes in size or density.
- Educate on the importance of regular interproximal cleaning around restorations and implants near #16.

- Schedule a **6-month recall** for reassessment of caries and periapical lesions.
 - Refer to an **endodontist** for definitive diagnosis and treatment planning for #45 and #43.
 - Consider **panoramic re-imaging** in 3–6 months to monitor root stumps and periapical pathology.
-
