# Medical Report

## Oral Panoramic X-Ray Examination Report

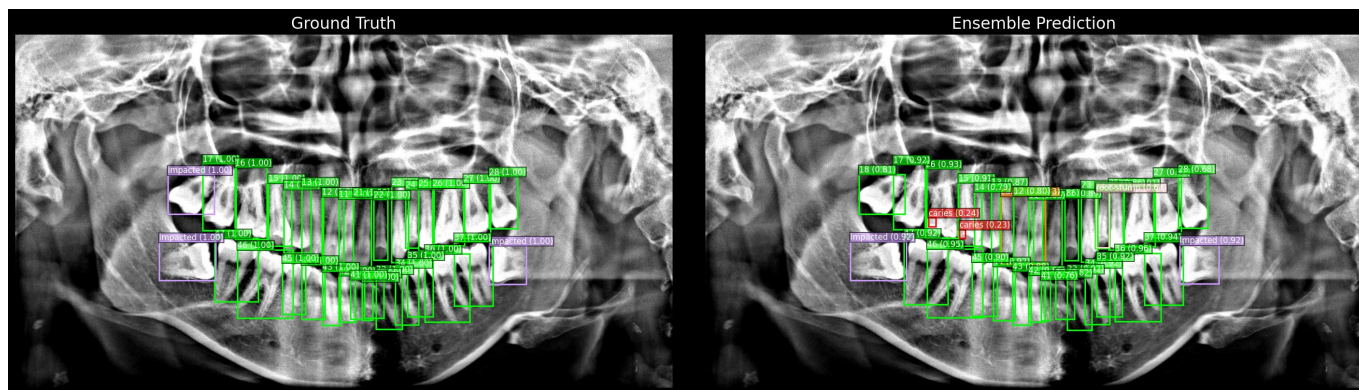
A total of 29 teeth are visualized within the panoramic image. Wisdom teeth (#18 and #28) are present and non-impacted. The maxillary right third molar (#18) is fully erupted, while the mandibular right third molar (#28) is visible but with reduced clarity in localization.

- **Tooth #11 (mandibular right lateral incisor):** Suspicious for calculus deposits.
- **Tooth #24 (maxillary left first premolar):** Suggests a root-stump, indicating prior extraction or resorption.
- **Near tooth #37 (mandibular right first molar):** Clear indication of an impacted tooth structure in the posterior mandible.
- **Near tooth #47 (maxillary right first molar):** Definitive evidence of an impacted tooth in the maxillary right posterior region.
- **Near tooth #16 (mandibular right first molar):** Areas of concern for caries in the mesial aspect.
- **Near tooth #15 (mandibular right second premolar):** Areas of concern for caries in the distal aspect.

No prior restorative treatments, crowns, root canal treatments, or implants are observed.

1. Impacted tooth near #37 (mandibular right first molar) and #47 (maxillary right first molar) requiring radiographic and clinical evaluation.
2. Root-stump in #24 (maxillary left first premolar) suggesting incomplete tooth removal or resorption.
3. Suspected caries near #16 (#15) and #15 (#16) necessitating close monitoring for progression.

- Reinforce oral hygiene protocols to mitigate calculus accumulation on #11.
- Monitor suspicious areas near #15/#16 for caries development.
- Provide dietary counseling to reduce cariogenic risk factors.

- **Urgent referral to oral surgeon** for assessment of impacted teeth near #37 and #47.
  - **Clinical correlation** for the root-stump in #24 to determine if extraction or surgical intervention is required.
  - **6-month recall** for radiographic reassessment of caries near #15/#16 and calculus in #11.
  - Schedule **follow-up within 3 months** for impacted tooth evaluation and treatment planning.
-
