Grounding Caption

Medical Report

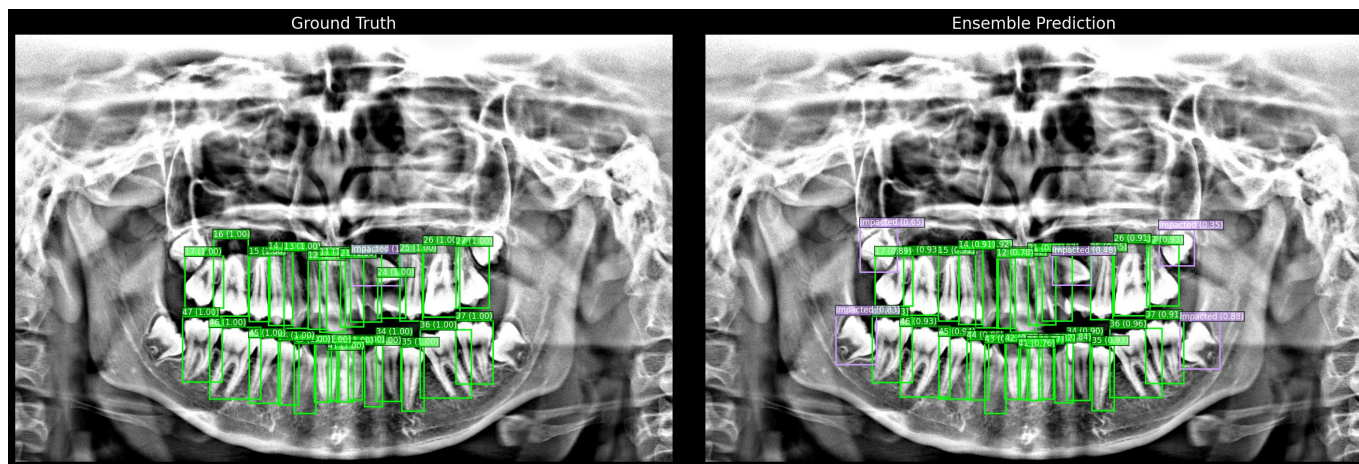
This localization caption provides multi-dimensional spatial analysis of anatomical structures and pathological findings for this panoramic dental X-ray image, including:

```
[
  {'box_2d': [1199, 722, 1300, 842], 'tooth_id': 'unknown', 'label': 'impacted', 'score': 0.88, 'near_tooth': '37'},
  {'box_2d': [330, 705, 431, 831], 'tooth_id': 'unknown', 'label': 'impacted', 'score': 0.83, 'near_tooth': '47'},
  {'box_2d': [390, 484, 484, 598], 'tooth_id': 'unknown', 'label': 'impacted', 'score': 0.65, 'near_tooth': '17'},
  {'box_2d': [876, 555, 975, 631], 'tooth_id': 'unknown', 'label': 'impacted', 'score': 0.48, 'near_tooth': '22'},
  {'box_2d': [1146, 491, 1235, 582], 'tooth_id': 'unknown', 'label': 'impacted', 'score': 0.35, 'near_tooth': '27'}
]
```

A total of 26 teeth are visualized on the panoramic radiograph. All four wisdom teeth (FDI #18, #28, #38, #48) are absent, indicating no erupted or identifiable impacted wisdom teeth within the field of view.

- **FDI #37 (mandibular right first molar):** Shows evidence of impacted tooth near the distal aspect, with radiographic signs of bony resistance.
- **FDI #47 (mandibular left first molar):** Demonstrates impacted tooth near the distal region, with adjacent cortical expansion observed.
- **FDI #17 (maxillary left first molar):** Suspicious for impacted tooth near the palatal surface, with equivocal radiopacity suggesting potential bony impaction.
- **FDI #22 (maxillary right first premolar):** Areas of concern noted for potential impacted tooth near the mesial aspect; however, low radiographic contrast limits definitive assessment.

- Impacted tooth near FDI #37 and #47 requires evaluation for surgical extraction due to potential for infection or resorption of adjacent teeth.
- Suspicious radiographic findings near FDI #17 warrant further imaging (e.g., CBCT) to clarify the extent of bony impaction and anatomical relationship.

- Reinforce oral hygiene protocols to mitigate periapical inflammation risks in impacted regions.
- Monitor areas of concern near FDI #22 during routine recalls for progression of radiographic changes.

- Immediate referral to an oral surgeon for clinical and radiographic assessment of impacted teeth near FDI #37, #47, and #17.
- Schedule a 6-month recall to reassess impacted regions and ensure no secondary complications (e.g., caries, periodontal compromise) arise.
