Grounding Caption

This localization caption provides multi-dimensional spatial analysis of anatomical structures and pathological findings for this panoramic dental X-ray image, including:

Medical Report

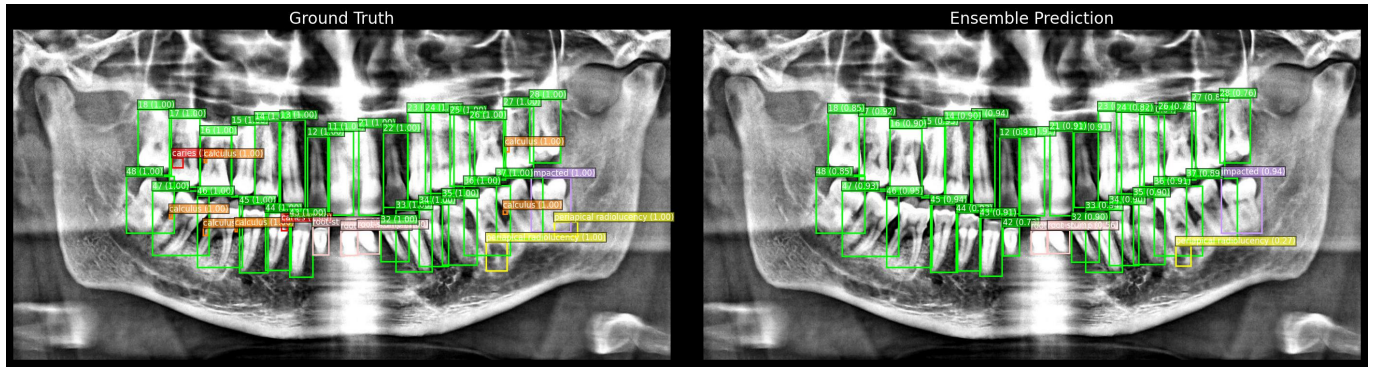
A total of 29 teeth are visualized on the panoramic radiograph. Three wisdom teeth are identified (#18, #48, and #28), all of which are present and not impacted.

- A clear indication of an impacted tooth is observed near #37.
- Areas of concern are noted for suspected root stumps near #42 and #32.
- A suspicious area of periapical radiolucency is identified near #36.

- Impacted tooth near #37 requires evaluation for potential surgical intervention.
- Suspected root stumps near #42 and #32 necessitate further assessment to determine if residual root fragments remain.
- Periapical radiolucency near #36 warrants investigation to rule out apical periodontitis or other pathology.

- Reinforce patient education on meticulous oral hygiene practices to prevent secondary caries and periodontal complications.
- Monitor suspicious periapical radiolucency and root stumps at follow-up appointments for progression.

- Schedule a 6-month recall for reassessment of the impacted tooth (#37) and suspected root stumps (#42, #32).
- Refer to an endodontist for detailed evaluation of the periapical radiolucency near #36.
- Consider cone-beam computed tomography (CBCT) for 3D visualization of the impacted tooth (#37) if surgical planning is required.
