Grounding Caption

Oral Panoramic Radiographic Report

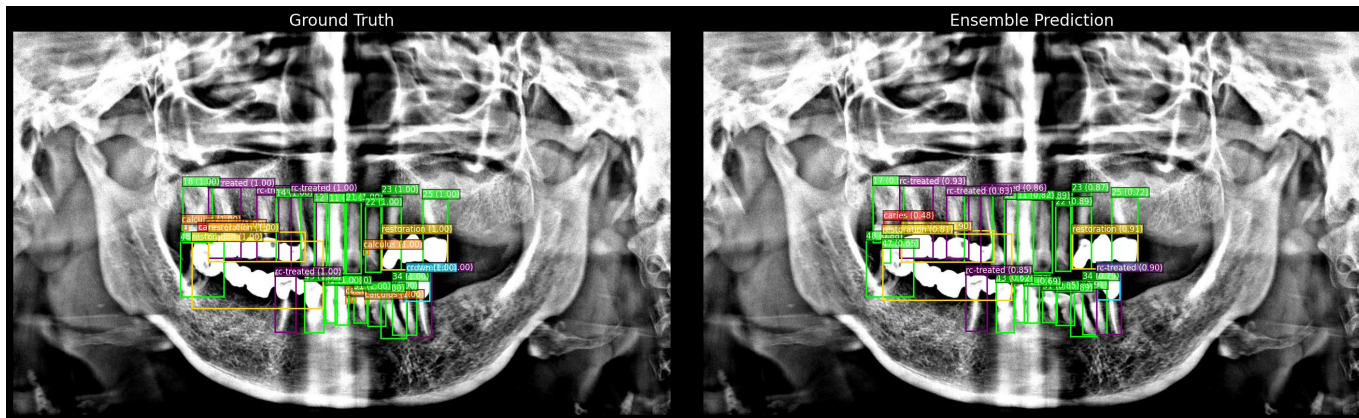
Teeth visibility with center points (total: 17):

Wisdom teeth detection (total: 1):

Dental Pathological Findings (total: 1):

Historical Treatments (total: 9):

- Panoramic visualization of **17 teeth** was achieved, with clear delineation of primary dental structures.
- **Wisdom teeth status:** A single mandibular right third molar (#48) is **fully erupted and unimpacted**. No other wisdom teeth were visualized.

- **Tooth #17 (mandibular left first molar):** A **suspected carious lesion** is noted in proximity, with radiographic features suggestive of early decay. No definitive evidence of pulpal involvement.
- No additional pathologies (caries, periapical pathology, or impactions) were identified in the visualized teeth.

- **Tooth #14 (maxillary left first premolar):** Presence of **multiple restorations** and **three distinct root canal-treated regions**, indicating prior endodontic therapy.
 - **Tooth #17 (mandibular left first molar):** **Root canal-treated** morphology with associated restorative material in proximity.
 - **Tooth #25 (maxillary right second molar):** **Restoration** present, consistent with previous indirect filling.
 - **Tooth #34 (mandibular right first molar):** **Crown** and **root canal-treated** anatomy, consistent with prior endodontic and prosthetic intervention.
 - **Tooth #43 (mandibular left second molar):** **Root canal-treated** anatomy in proximity.
-

- **Suspected carious lesion near #17** requires further clinical correlation and monitoring.
- **Multiple endodontically treated teeth (#14, #17, #34, #43)** may warrant evaluation for long-term prognosis and need for retreatment or apical surgery.

- Reinforce **oral hygiene protocols** to mitigate caries risk in #17.
- **Monitor areas of suspected calculus** in the posterior segments (e.g., near #14 and #25) with periodic recall.

- **6-month recall** recommended for reassessment of #17 and other restorations.
 - **Referral to endodontist** advised for #14 and #17 to evaluate root canal status and potential apical pathology.
 - Consider **restorative intervention** for #17 if caries progression is confirmed clinically.
-
