Grounding Caption

This localization caption provides multi-dimensional spatial analysis of anatomical structures and pathological findings for this panoramic dental X-ray image, including:

Medical Report

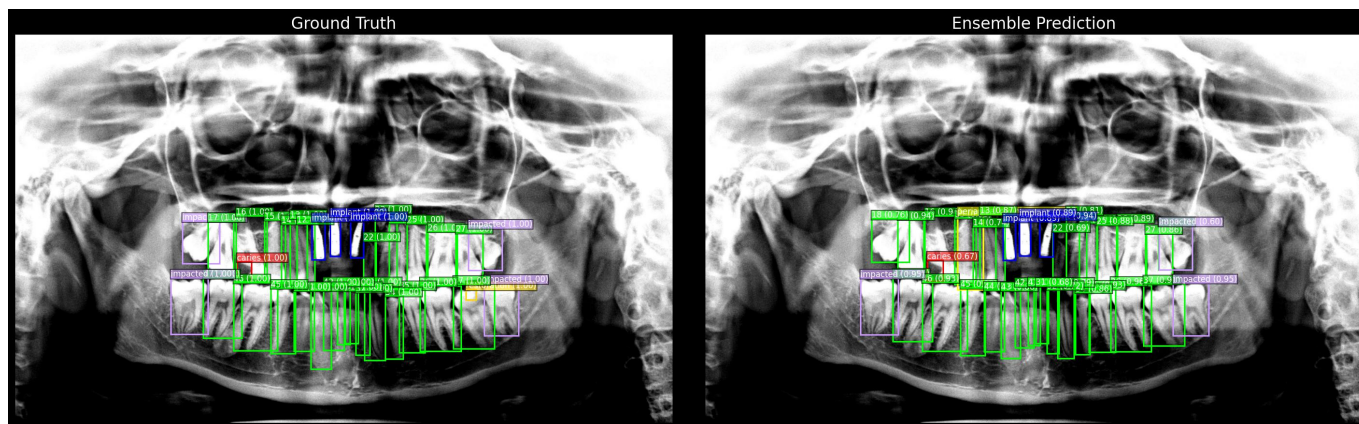
A total of 27 teeth are visualized, with all molars and premolars accounted for. Wisdom teeth (#18 and #28) are present; #18 is fully erupted and unimpacted, while #28 exhibits impaction. No evidence of tooth loss is observed.

- #15: Suspicious for periapical radiolucency.
- #28: Suspicious for wisdom tooth impaction.
- Near #37: Clear indication of impacted anatomical structure.
- Near #47: Clear indication of impacted anatomical structure.
- Near #16: Suspicious for carious lesion.

- Near #22: Presence of a dental implant.
 - Near #13: Two dental implants identified.
-

- Impacted wisdom tooth (#28) requires evaluation for surgical extraction due to potential risk of infection or resorption.
- Suspicious periapical radiolucency on #15 necessitates endodontic assessment to confirm apical pathology.
- Carious lesion near #16 demands diagnostic confirmation and prompt restorative intervention.
- Impacted structures near #47 and #37 warrant further imaging (e.g., CBCT) to clarify anatomical relationships.

- Reinforce oral hygiene protocols, emphasizing interproximal cleaning for high-risk areas (#16, #28).
- Monitor suspicious periapical radiolucency (#15) for progression.
- Educate on dietary modifications to reduce caries risk.

- 3-month recall for re-evaluation of #15's periapical status.
- Referral to oral surgeon for impacted wisdom tooth (#28) management.
- Schedule endodontic consultation for #15.
- 6-month recall for general monitoring of implants and suspicious lesions.
