## Grounding Caption

## Medical Report

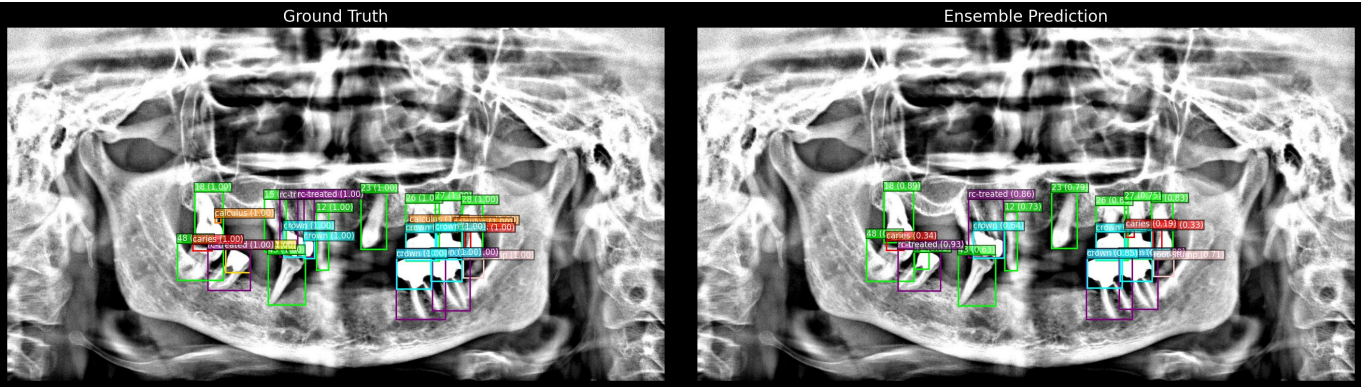
This localization caption provides multi-dimensional spatial analysis of anatomical structures and pathological findings for this panoramic dental X-ray image, including:

A total of 9 teeth were visualized in the panoramic projection. The left lower first molar (#28), upper right third molar (#48), and upper left third molar (#18) are present and unimpacted. No radiographic signs of active periodontal disease or

widespread radiolucencies were observed.

- **#28**: Suspicious for a root stump near the distal aspect.
- **#48**: Areas of concern noted for potential carious involvement at the mesial surface.
- **#28**: Suspected carious lesion at the distal surface.
- **#27**: Areas of concern for early carious demineralization at the mesial surface.

- **#26**: Presence of a full-coverage crown with evidence of prior root canal treatment.
  - **#27**: Full-coverage crown and root canal-treated tooth.
  - **#12**: Root canal-treated tooth with a partial crown.
-

- Immediate attention required for suspicious root stump near #28.
- High-priority carious involvement in #48 and #28, necessitating prompt restorative intervention.
- Monitor low-confidence carious concern near #27 for progression.

- Reinforce interdental cleaning techniques for #28 and #48 to mitigate caries risk.
- Recommend professional scaling to address suspected calculus deposits.
- Apply fluoride varnish to high-risk surfaces (#28, #48).

- Schedule recall in 6 months for reassessment of #27 and #28.
- Refer to endodontist for evaluation of root stump near #28.
- Initiate restorative treatment for #48 and #28 within 2 weeks.
