Grounding Caption

Medical Report

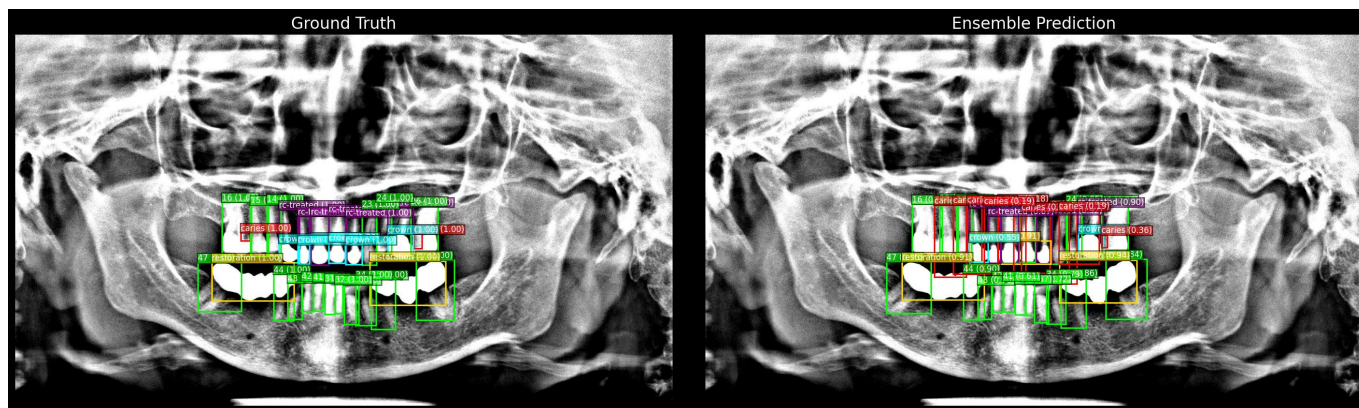
A total of 19 teeth were visualized within the panoramic image. No wisdom teeth (third molars) were detected bilaterally. All remaining teeth demonstrate normal anatomical positioning, with no evidence of gross structural displacement or fractures.

- **#15 (#15)**: Suspicious for early caries on the distal aspect, with areas of concern noted for demineralization.
- **#23 (#23)**: Suspected caries on the mesial surface, with radiolucent changes consistent with interproximal decay.
- **#14 (#14)**: Radiolucent lesion suspicious for caries on the occlusal surface.
- **#11 (#11)**: Areas of concern for caries on the mesial aspect.
- **Near #26 (#26)**: Radiolucent region suspicious for caries adjacent to the distal root.
- **Near #14 (#14)**: Suspected caries lateral to the existing root canal-treated tooth.
- **Near #23 (#23)**: Radiolucent changes adjacent to the interproximal restoration.
- **Near #24 (#24)**: Suspicious for caries near the cervical margin of a crown.
- **Near #11 (#11)**: Radiolucent region adjacent to the root canal-treated tooth, suggesting possible secondary caries.

- **#11 (#11)**: Presence of root canal-treated tooth with a composite restoration on the mesial surface. A second root canal-treated tooth is noted adjacent to this region.
 - **Near #37 (#37)**: A restoration is present on the buccal aspect of the apical region.
 - **Near #14 (#14)**: Root canal-treated tooth with a crown placed on the adjacent structure.
 - **Near #23 (#23)**: Root canal-treated tooth identified proximal to the restoration.
 - **Near #44 (#44)**: Restoration on the distal surface of a missing wisdom tooth area.
 - **Near #24 (#24)**: Crown placed on the cervical region of a root canal-treated tooth.
-

1. **Caries risk in multiple locations**: High suspicion of caries on #15, #23, #14, and #11, with additional concerns near #26, #14, #23, #24, and #11.
2. **Secondary caries near restorations**: Noted near #23 and #24, requiring evaluation for recurrent decay.
3. **Root canal-treated teeth**: #11 and #23 demonstrate potential secondary caries or marginal breakdown.

- Reinforce meticulous interproximal plaque control using floss or interdental brushes, particularly between #15/#14 and #23/#24.
- Implement fluoride therapy for caries-prone regions to enhance remineralization.
- Monitor areas near restorations and crowns for recurrent decay during routine evaluations.

- **6-month recall** for radiographic and clinical reassessment of caries-prone teeth (#15, #23, #14, #11) and adjacent suspicious regions.

- Referral to endodontic evaluation for #11 and #23 if apical radiolucencies suggest root canal compromise.
- Consider prophylactic restoration for #14 and #15 if caries progression is confirmed on follow-up imaging.
