Grounding Caption

Oral Panoramic X-ray Examination Report

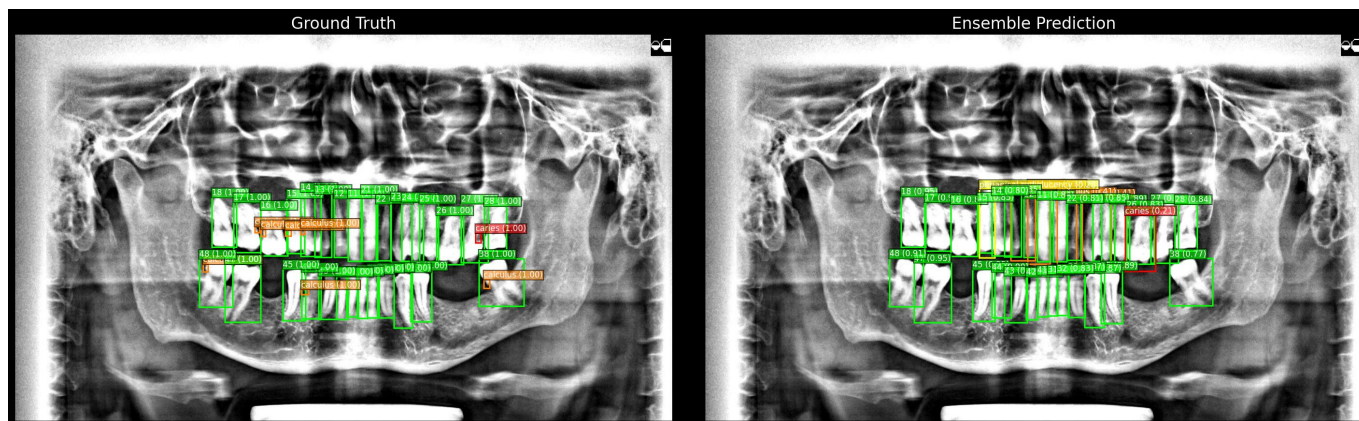
A total of 29 teeth were visualized on the panoramic radiograph. All four wisdom teeth (#18, #48, #28, #38) are present and unimpacted. The dental arches demonstrate normal alignment with no apparent fractures or malpositions.

- **Suspected calculus deposition** noted on #23, #12, and #21.
- **Areas of concern for periapical radiolucency** identified near #15 (FDI 15).
- **Suspicious for carious lesion** on #26 (FDI 26), consistent with early enamel demineralization.

1. **Deep caries on #26** requires immediate intervention to prevent pulp involvement.
2. **Periapical radiolucency near #15** necessitates further evaluation (e.g., CBCT) to rule out apical periodontitis.

- Reinforce biofilm control protocols to mitigate calculus progression on #12, #21, and #23.
- Educate on diet modification to reduce caries risk, particularly for #26.

- Schedule **6-month recall** for reassessment of calculus and radiographic changes.
 - **Referral to endodontist** for #15 to determine apical pathology.
 - **Dental operative treatment** (restoration) prioritized for #26 within 2 weeks.
-
